**Pervious Concrete Accessible Pathways:
Usability for Individuals with Disabilities**

THESIS

Submitted as partial fulfillment of the requirements
for the degree of Doctor of Philosophy in Civil Engineering
in the Graduate College of the
University of Illinois at Chicago, 2019

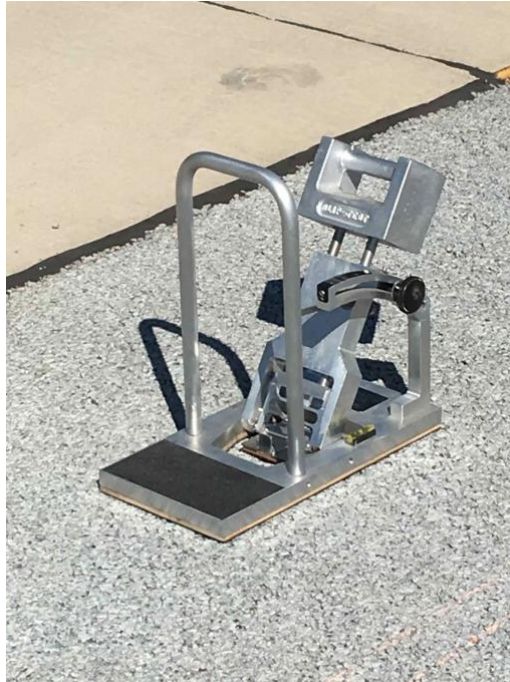
The device used to measure the coefficient of friction is the Brungraber Mark IV, shown in Figure 7, a more mobile version of the Mark I referred to earlier. The device allows a mass to be dropped in a controlled manner, producing contact between a 7.6 cm x 7.6 cm (3 in x 3 in) leather "shoe" and pathway surface. A graduated scale along the arc of angle of approach indicates the coefficient of friction of the surface, and is recorded at the first instance of the shoe slipping on the surface when contact is made.

Figure 7. Brungraber Mark IV device (Slip-Test, Inc., Spring Lake, NJ).

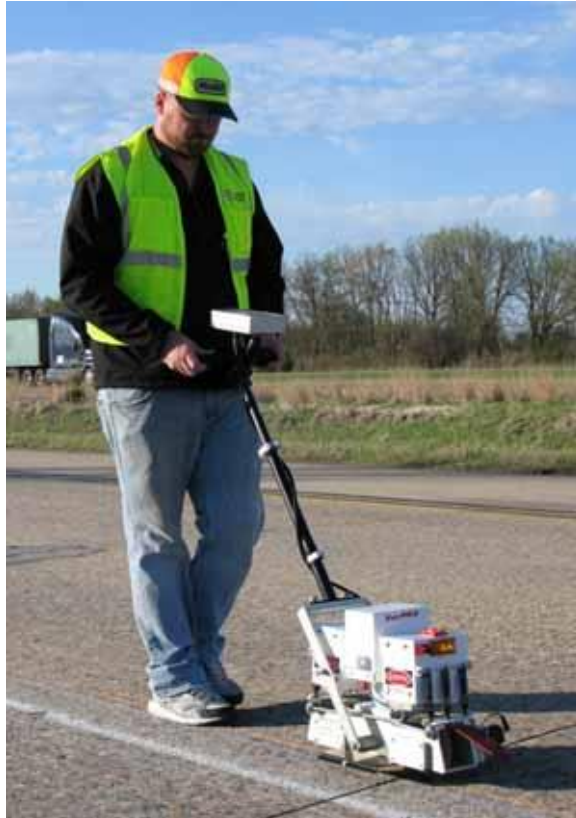
Use of the current SurPRO 4000 offered several advantages. The device is accepted by the concrete industry and inspection professionals for use on roadways (to measure road roughness for acceptance upon construction completion or the need for replacement when service life is at an end) and warehouse flooring. The device also allows variation in the sampling frequency (1, 5.08, or 10 mm), 1mm was used for the

Figure 8. SurPRO 4000 device in use (International Cybernetics, Largo, FL).

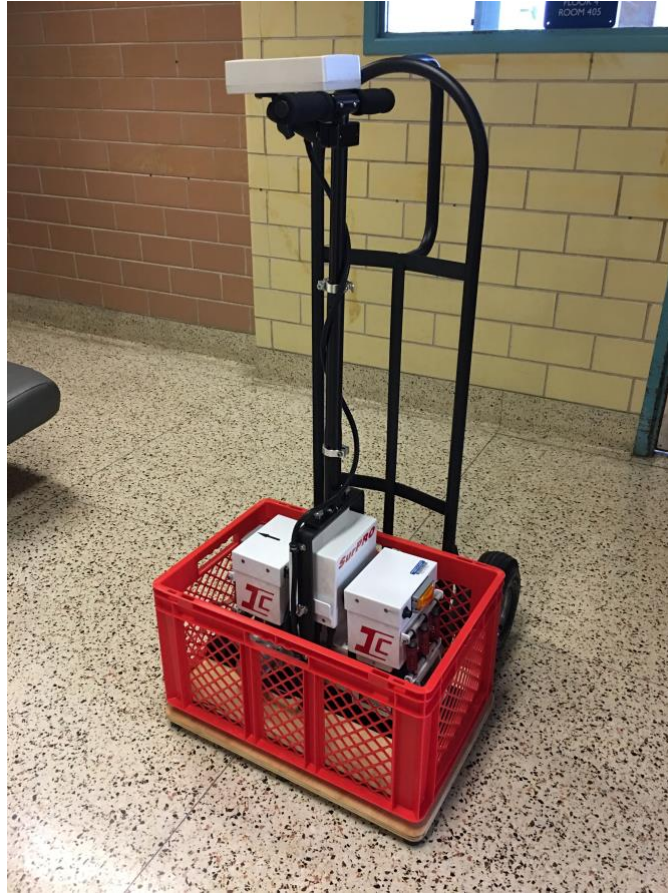
Figure 9. SurPRO 4000 in custom-fabricated cart, allowing transport to sites.

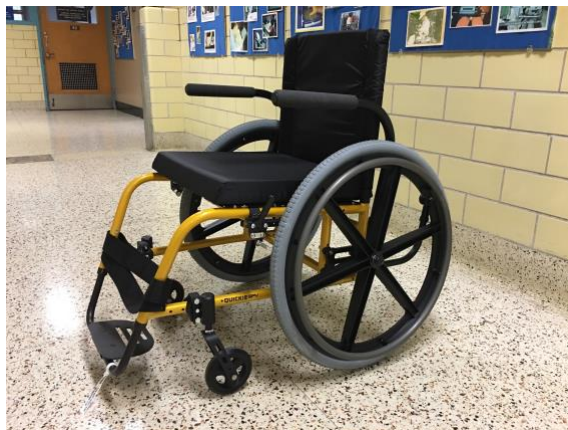
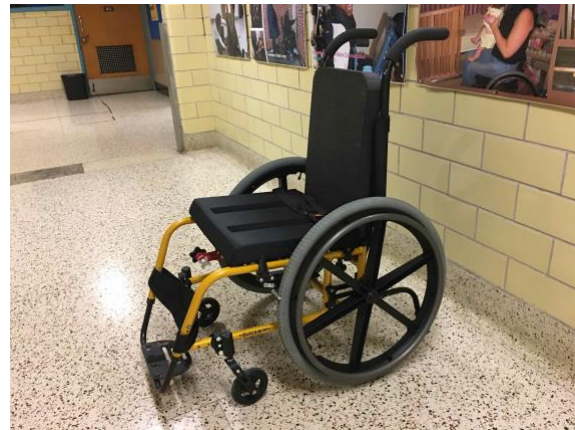
Figure 10. Sunrise Quickie GPV manual wheelchair used for whole-body vibration data collection: (a), standard configuration, (b), study configuration, with armrests removed and taller backrest.

The wheelchair was selected in consultation with the UIC Assistive Technology Unit Seating and Wheeled Mobility Group Leader. The specific model, a Sunrise Medical Quickie GPV, weighs 11.2 kg (23.6 lbs), and is shown in Figure 10. It is comprised of a rigid frame, single footplate, sling seat with 5.08 cm (2 in) polyurethane seat cushion, and sling backrest. A tall backrest cane was retrofitted onto the wheelchair, to better support the torso of the ANSI/RESNA WC-1 mannequin. The wheelchair has 61.0 cm (24 in) pneumatic rear tires and 12.7 cm (5 in) diameter solid polyurethane front casters. No shock-absorbing front caster hardware was present.

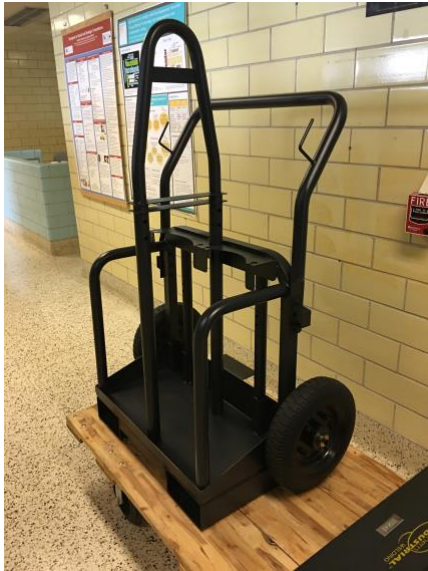
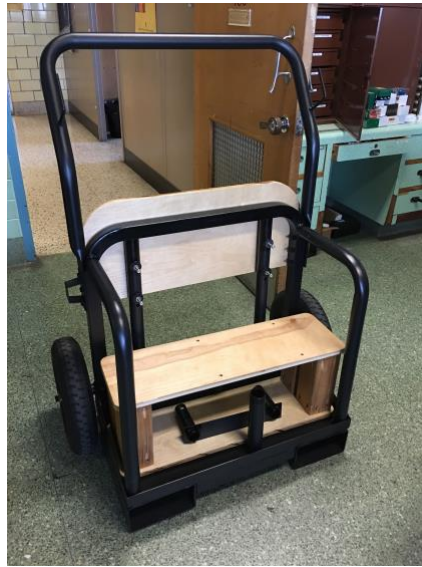
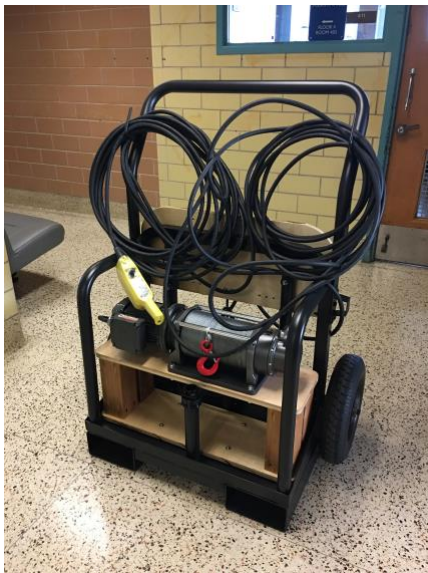
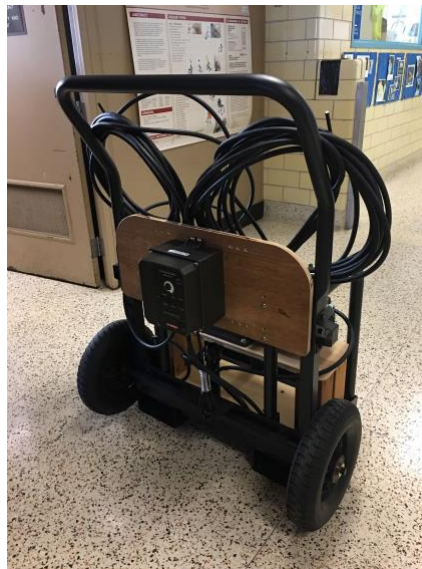
Figure 11. Welding tank cart and winch assembly, from top left: (a) un-adapted welding tank cart, (b) adapted welding tank cart, (c) adapted welding tank cart and winch-front, (d) adapted welding tank cart and winch-rear.

The initial experimental design included propulsion of the data collection manual wheelchair via the researcher pushing at a constant velocity. To increase the likelihood of a constant velocity which did not fluctuate with the investigator's gait, consideration was given to the use of a winch to pull the data collection manual wheelchair for the entire length of the trial path. An adapted welding tank cart and winch involved in the set up are shown in Figure 11.

Two issues emerged when this design concept was investigated. First, the trial path length, at 30 m, would result in the winch cable being prone to sagging under its own weight. Second, the relatively low force required to pull the data collection wheelchair, measured at approximately 44 N (10 lb) during simulated trial runs, was not constant. During trial runs, this produced periods of intermittent slack in the cable, and fluctuating velocity. An attempt was made to introduce an opposing force to ensure that the cable would remain taught via a following walker with spring connection (Figure 12), but this had limited effectiveness. As such, this method of propelling the data collection manual wheelchair was abandoned.

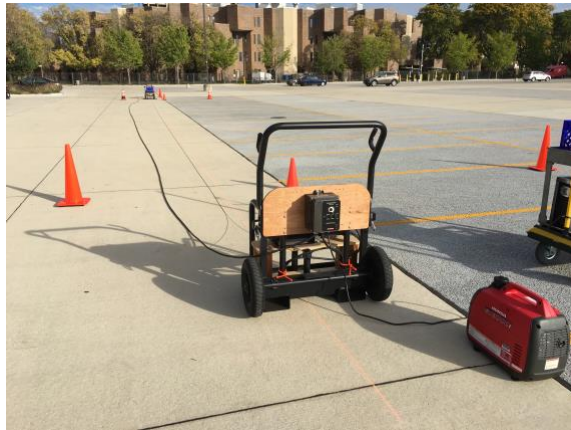
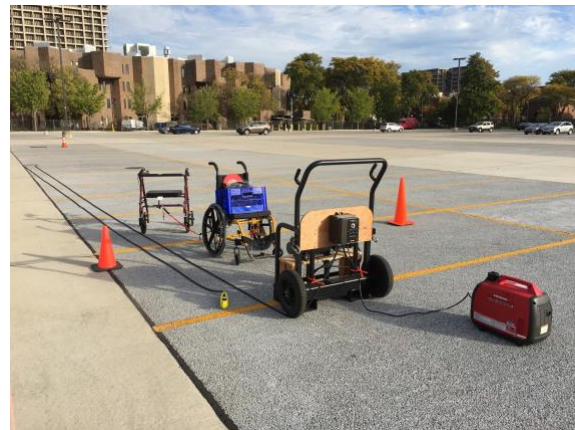
Figure 12. (a) Adapted welding tank cart-winch assembly shown during trial data collection; (b) Assembly with walker providing following force. Note that method of providing force at rear of data collection manual wheelchair and the use of a portable generator had to be introduced.

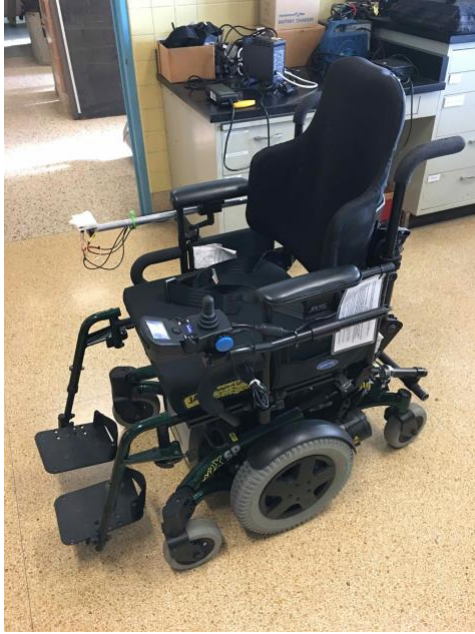
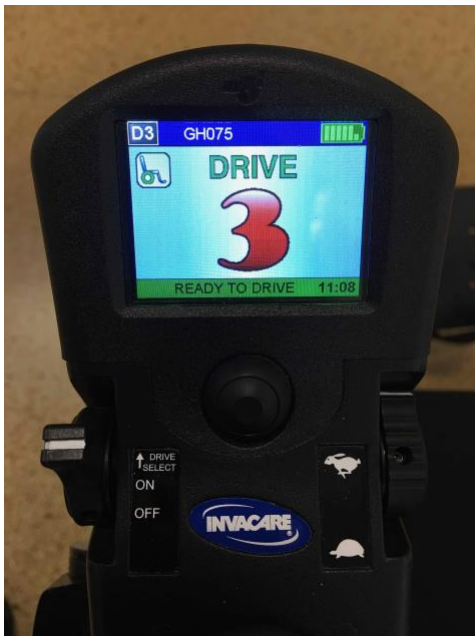
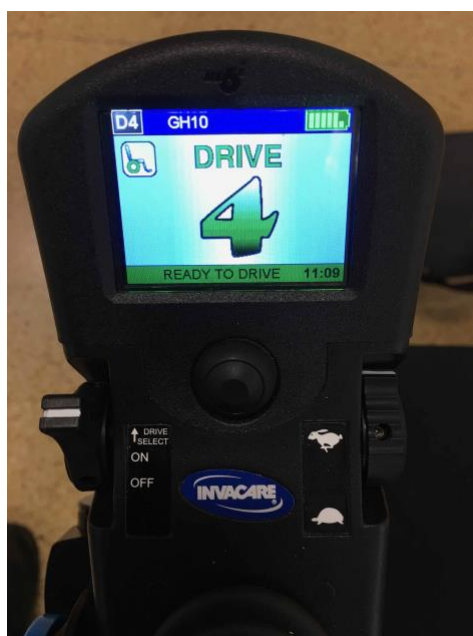
Figure 13. Powered wheelchair used to tow the data collection manual wheelchair: (a) Invacare TDX-SP wheelchair, (b) programmer for MK circuitry, (c) drive mode for 0.75 m/s travel, (d) drive mode for 1.00 m/s travel).

To produce a constant velocity scenario, the concept of towing the data collection manual wheelchair with a powered wheelchair was investigated. Use of a powered wheelchair would have the advantage of being able to be used on any trial path where the data collection manual wheelchair was used, straight or slightly curved. Most importantly, by using a powered wheelchair with programmable circuitry, the required data collection manual wheelchair velocity could be achieved in the lab and merely verified in the field at each site. The powered wheelchair selected was an Invacare TDX SP model, with MK circuitry. Drive modes were set to match with the required data collection manual wheelchair run velocities, with the ability to fine-tune the velocity in the field if necessary. Figure 13 shows the wheelchair, programmer, and drive mode display.

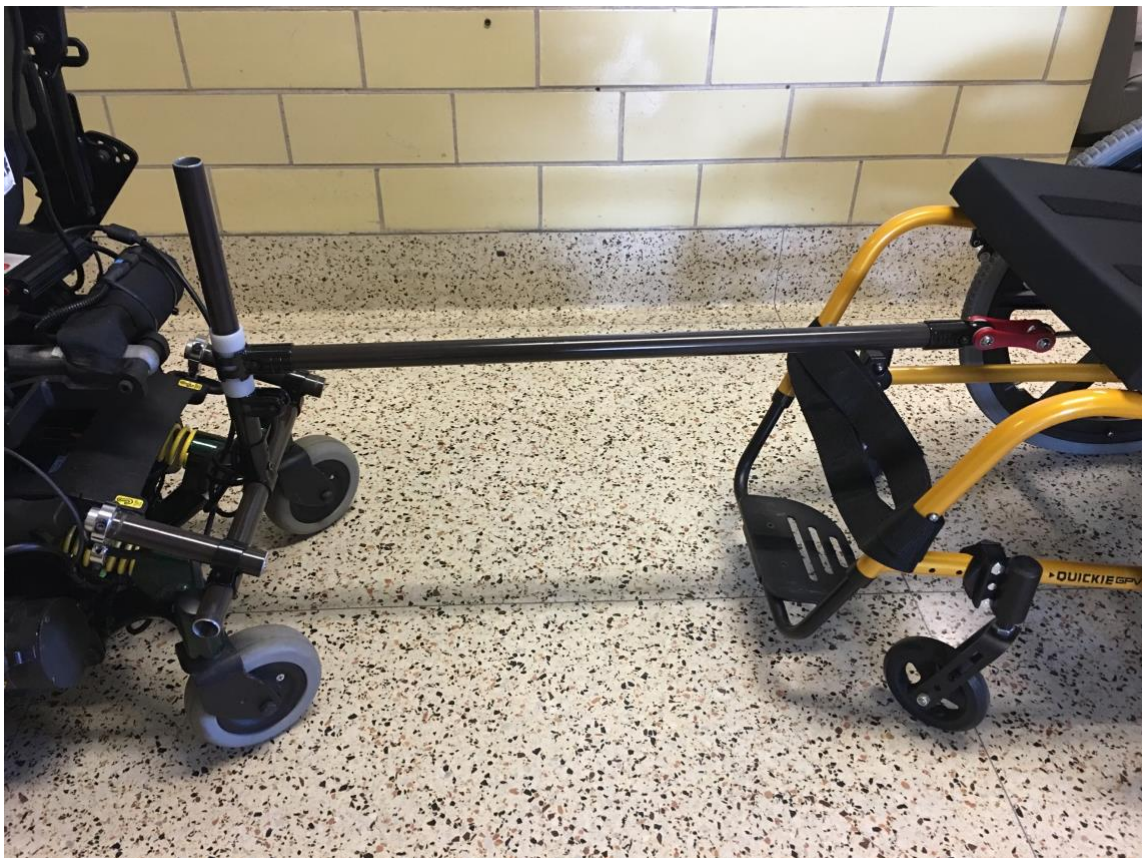
For the connection between the powered wheelchair and the data collection manual wheelchair, a custom tow bar was constructed using tubing and fittings from a modular materials handling system manufacturer. With a vertical tube attached to the powered wheelchair, tube attached as the horizontal connection (free to rotate in the XY plane via slip-fit sleeve), and 3-D printed flexible link attachment point to the data collection manual wheelchair, towing could occur without introducing any restriction in movement of the data collection manual wheelchair. Figure 14 shows the arrangement of these components. Figure 15 shows the flexible link.

Figure 14. Custom tow bar between powered wheelchair and data collection manual wheelchair (Creform Material Handling Systems, Greer, SC).

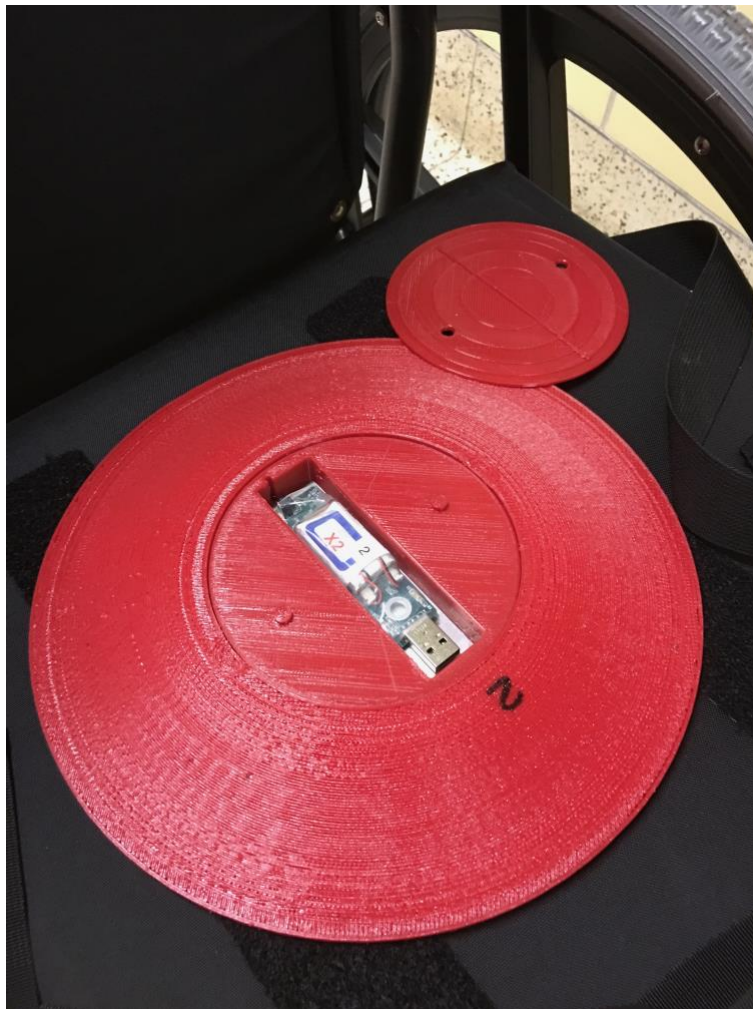
The final assembly of the base, filler, lid, and accelerometer provided the specified overall size and shape of the holder, and protection of the accelerometer (Figure 19).

Figure 19. Accelerometer holder components, assembled.

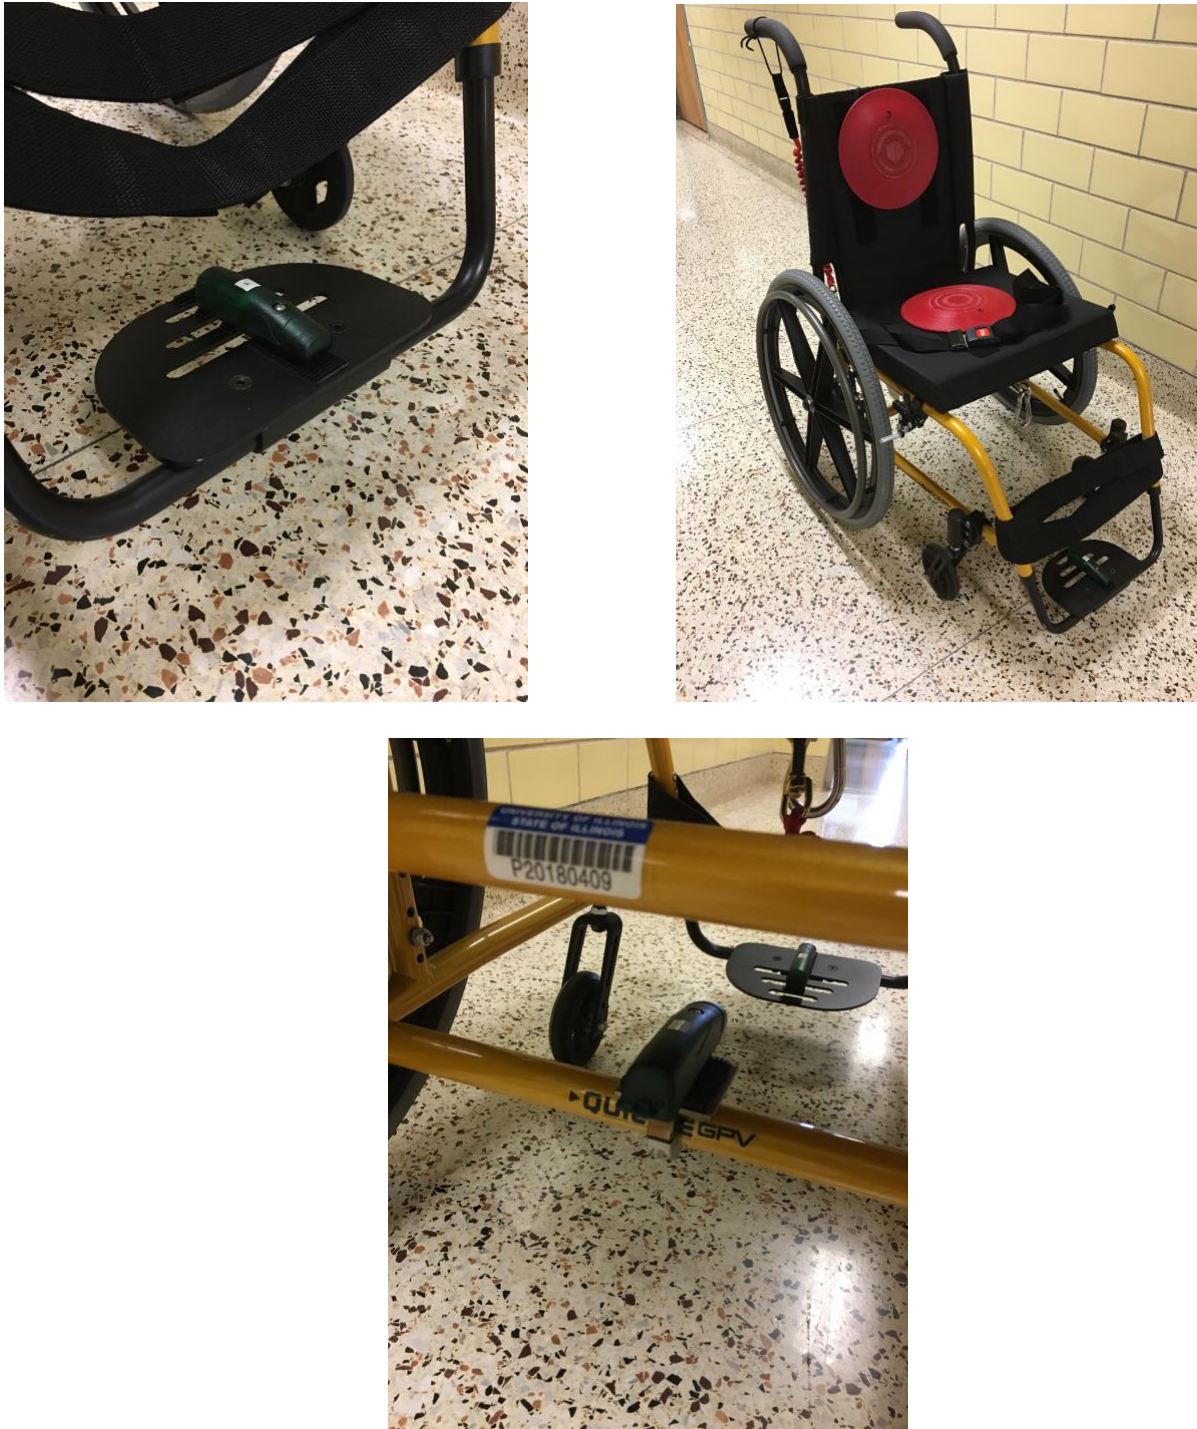
Figure 20 shows the location of each accelerometer.

Figure 20. (a) A1 at footplate, (b) A2 at seat and A3 at backrest, (c) A4 at wheelchair frame cross member.

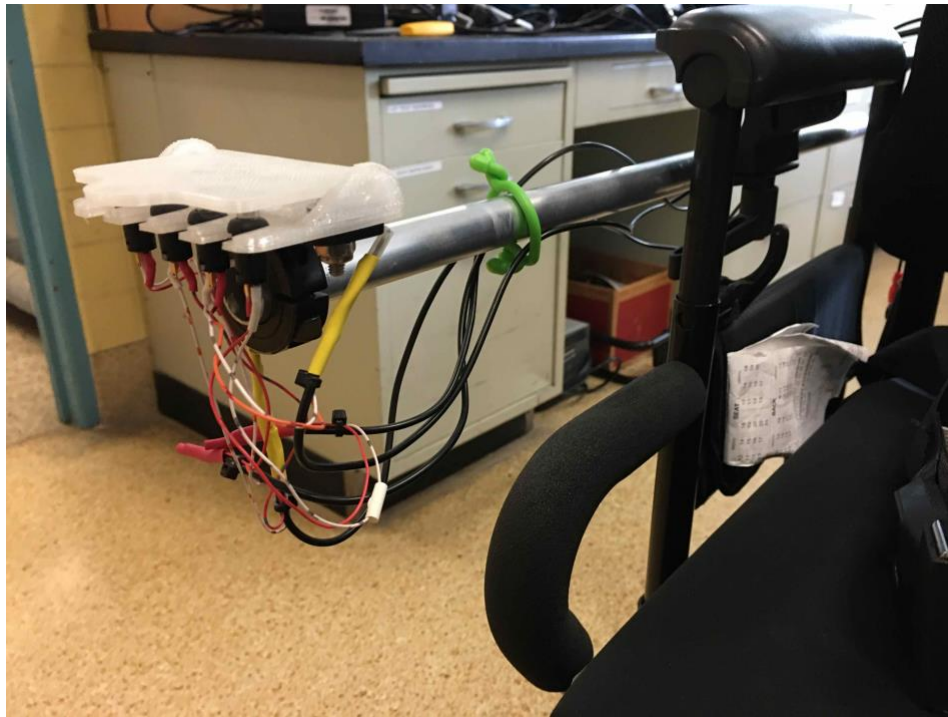
Custom wiring to the on/off switches proved challenging as well. The ideal configuration of a cable that would provide control of all 4 accelerometers via one switch was attempted, but due to high sensitivity of the accelerometers to slight changes in voltage, and durations of the switch closures, consistent simultaneous control of all 4 was not achieved. Instead, a custom 3D-printed holder and hinged lid was fabricated, to allow control of the 4 switches simultaneously (Figure 22).

Figure 22. 3D-printed switch holder and activation lid.

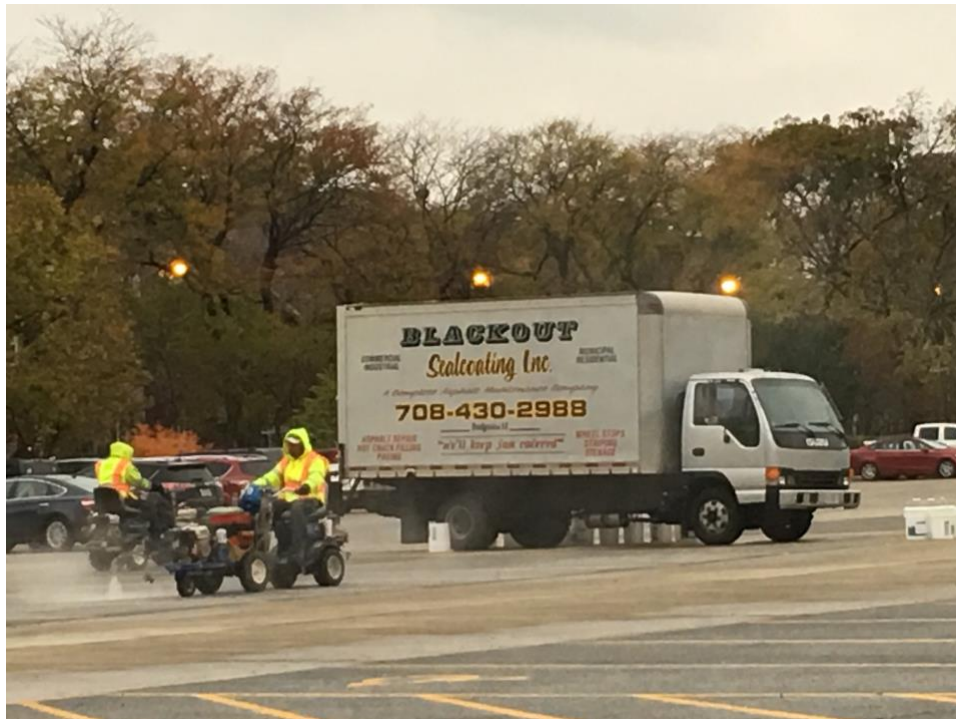
cleaning and sealant schedule at a given location, as a recent application of sealant or microbial solution may produce a surface coefficient of friction, for a period of time, which brings the pathway out of compliance regarding slip-resistance. Figure 27 shows a contractor applying sealant at the CP1 site.

Figure 27. Sealcoating crew at location CP1.

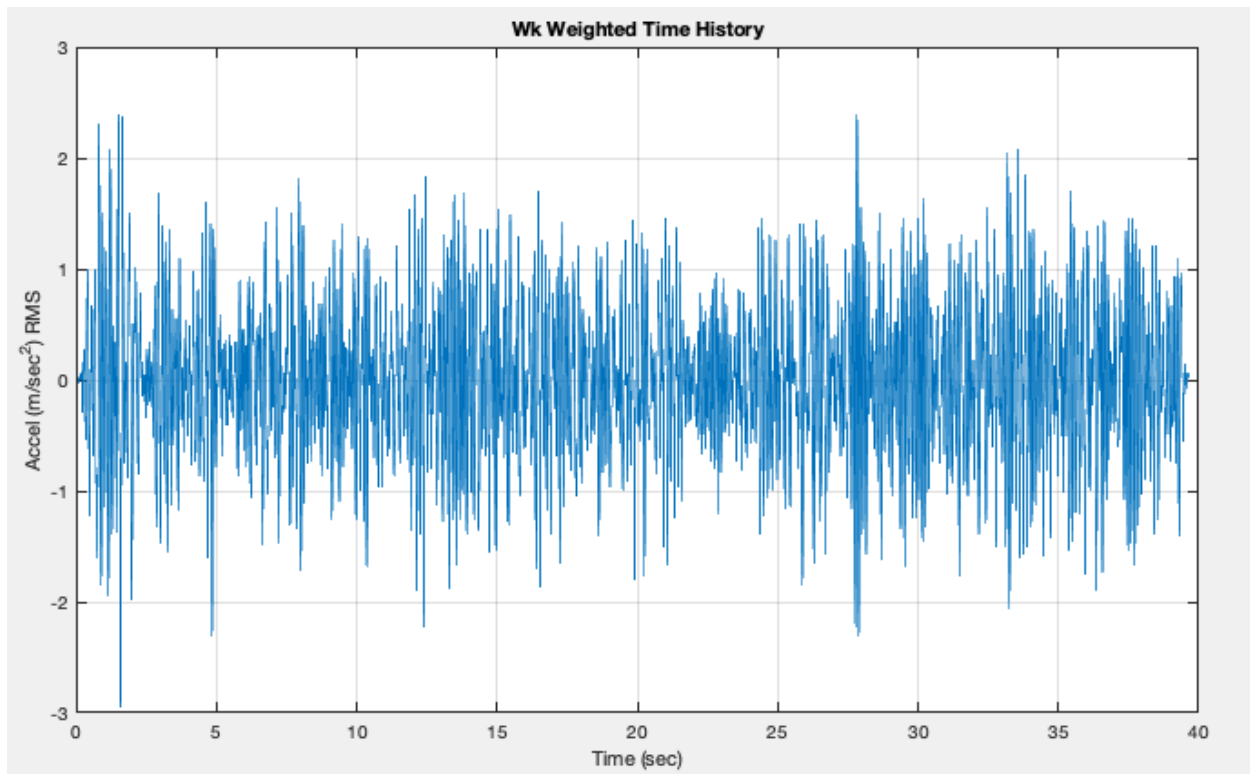
To calculate whole-body vibration, a Matlab program based on ISO 2631-1:1992 was utilized. The program *vibrationdata.m* is an open-source program utilized by ergonomists to take acceleration data and produce frequency-weighted whole-body vibration results. For acceleration data taken at the seat, in the z-direction, a frequency weighting value W_k is taken as 1.00 for the calculations (Mansfield, 2005).

Figure 34. Typical accelerometer output plot (CP8, 0.75 m/s, A2).

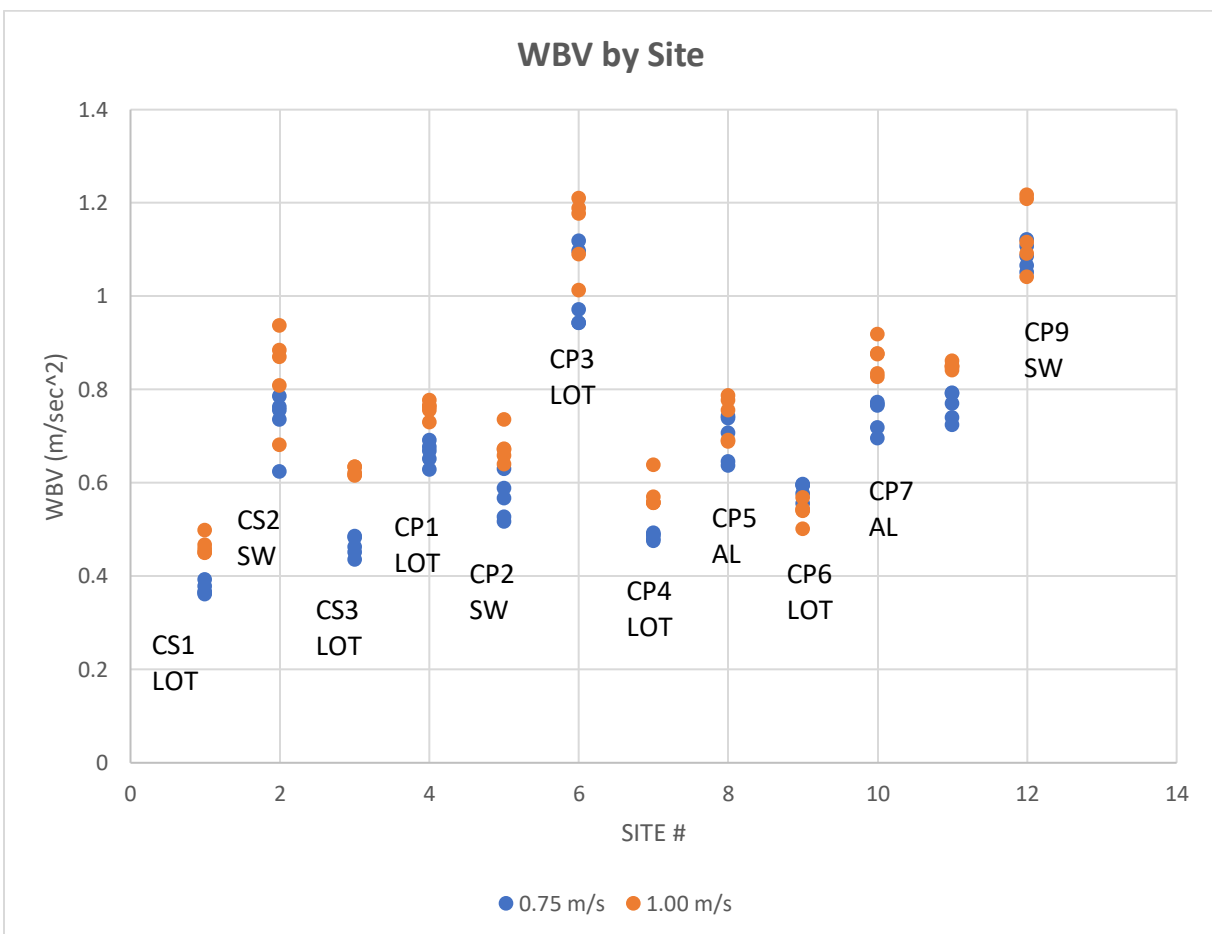
Figure 36. Whole-body vibration by Site (individual data points).

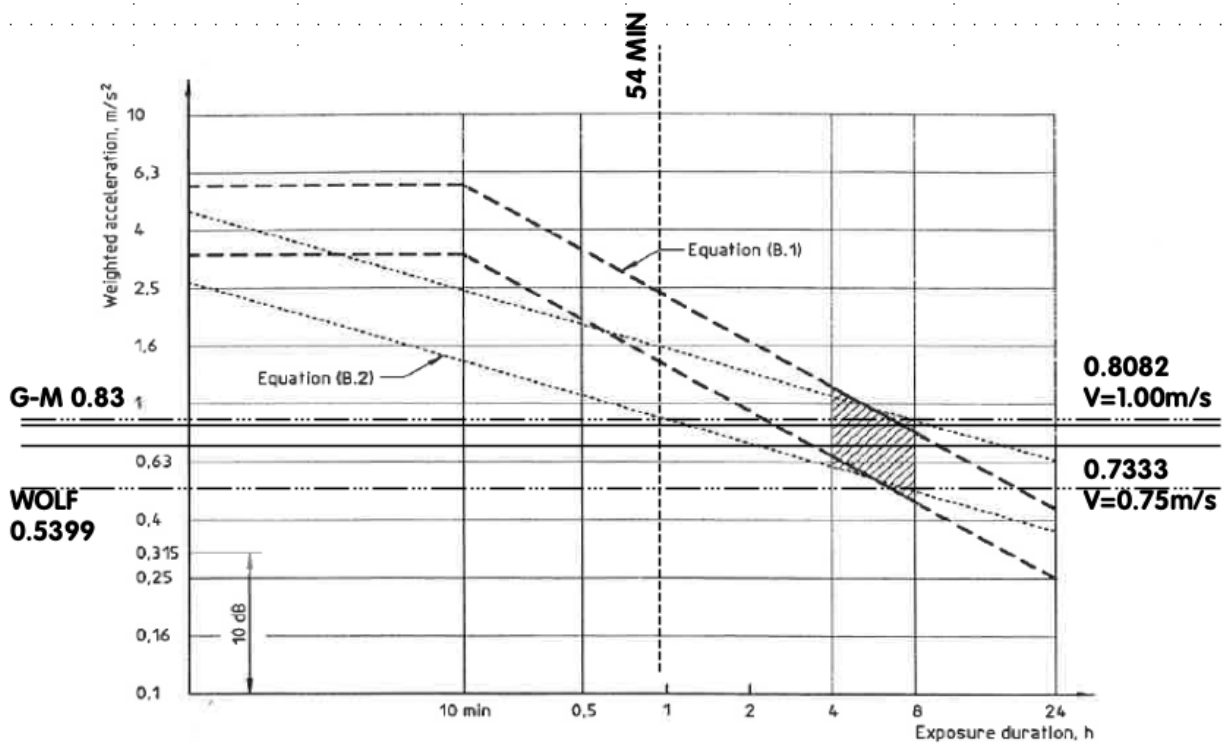
Finally, adding data from the Garcia-Mendez and Wolf studies, the study's whole-body vibration levels seem in line with previous work (Figure 44).

Figure 44. ISO 2631-1:1992, Annex B, Health guidance caution zones, with whole-body vibration data from Garcia-Mendez and Wolf added.

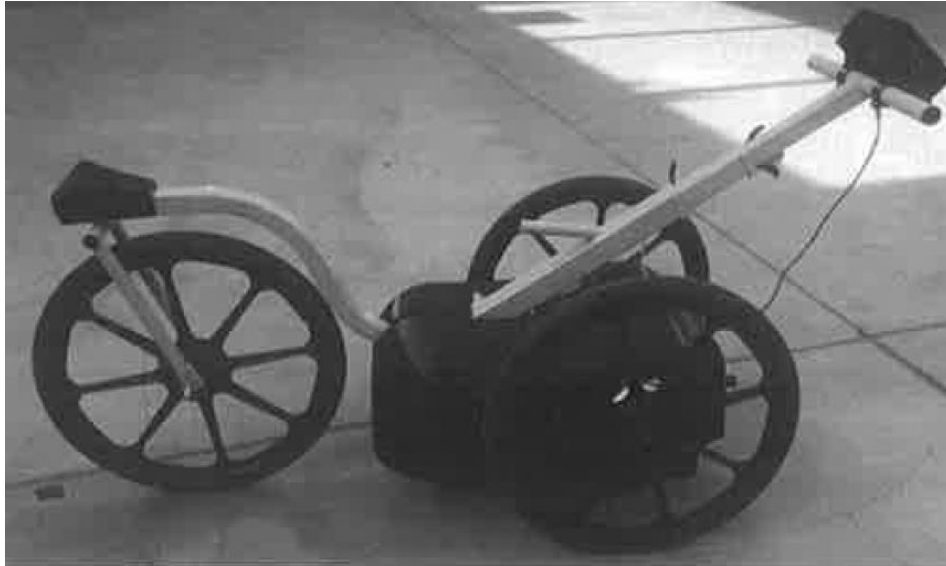
Further study is needed to see if any commercially available road roughness device has a wheel diameter of 70 mm (2.75 in), so that the data can be used by ASTM E3028 properly. While the University of Pittsburgh states that it PathMeT device is the only one suitable for pathway roughness measurement (Duvall, 2016) to yield ASTM E3028 figures, it is questionable how many construction firms and inspection officials will have this device at their disposal (Figure 45).

Figure 45. University of Pittsburgh PathMeT data collection device.
