Wear Behavior Of Polyethylene Against Titanium Nitride Coated Alloy Surfaces For Joint Replacement

THESIS

Submitted as partial fulfillment of the requirements
for the degree of Master of Science in Bioengineering
in the Graduate College of the
University of Illinois at Chicago, 2020

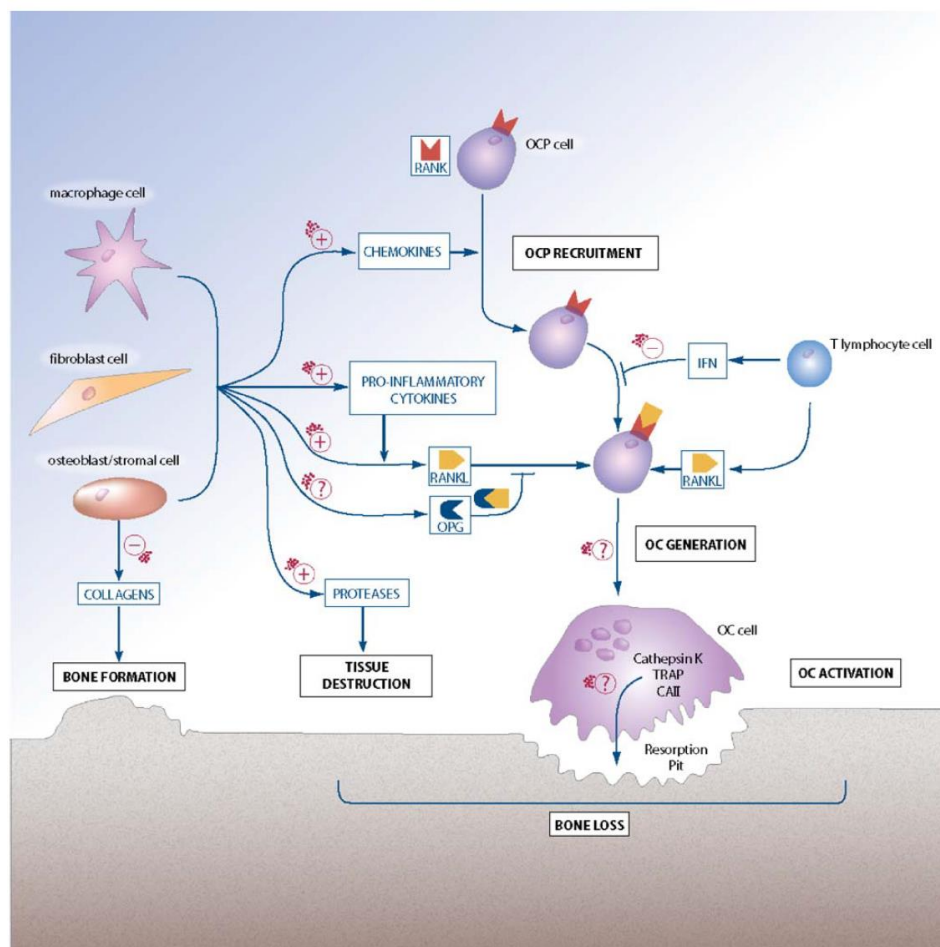
Figure 2: Cellular and molecular pathways of the osteoclast genesis and influence of wear debris particles in bone resorption process – [11].

As shown in the image that has been reported on the following page, when entering the human tissues, the most important cell type that is activated by the wear debris are the macrophages, that may respond in two different ways, both contributing to the periprosthetic resorption of bone tissue. First of all, they contribute to the activation of the inflammatory cascade that ends with osteoclast recruitment and activation(11), but recent studies (12) have also demonstrated that wear products also inhibit the protective effect of antiosteoclastogenic cytokines like interferon-gamma, increasing differentiation of macrophages into osteoclasts.

In particular, when the inflammatory process starts osteoclast precursor cells (OCP) differentiate into functional osteoclasts that are responsible for the bone resorption process. This activation is mediated by a wide range of different factors such as *chemokines* or *pro-inflammatory cytokines* that are released by macrophages and other cells that are responsible for the positive (+) or negative (-) modulation of the process.

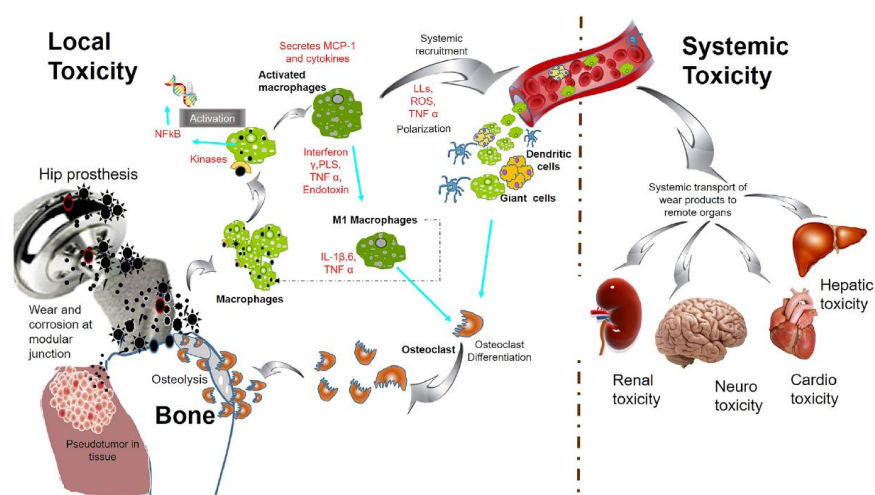
Figure 3: Schematic of the adverse reaction caused by the release of metal ions - [13].

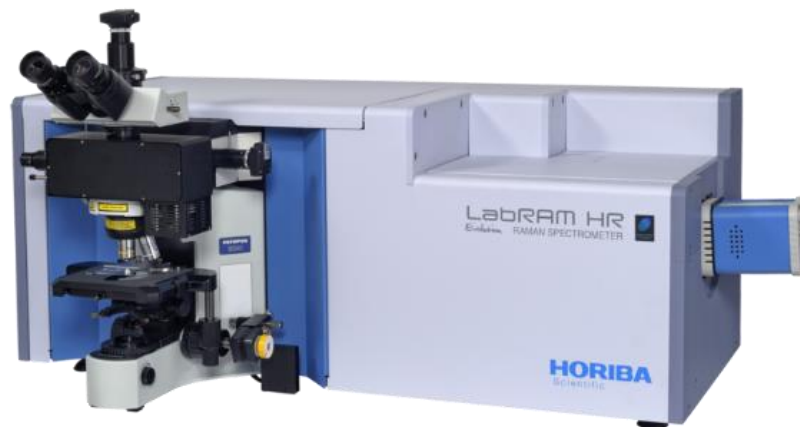
Figure 16: HORIBA LabRAM HR Evolution – [34]

In order to perform a complete characterization of the discs before and after the wear test, it has also been performed Raman spectroscopy on the surface of all the samples. HORIBA LabRAM HR Evolution has been used to complete this analysis.

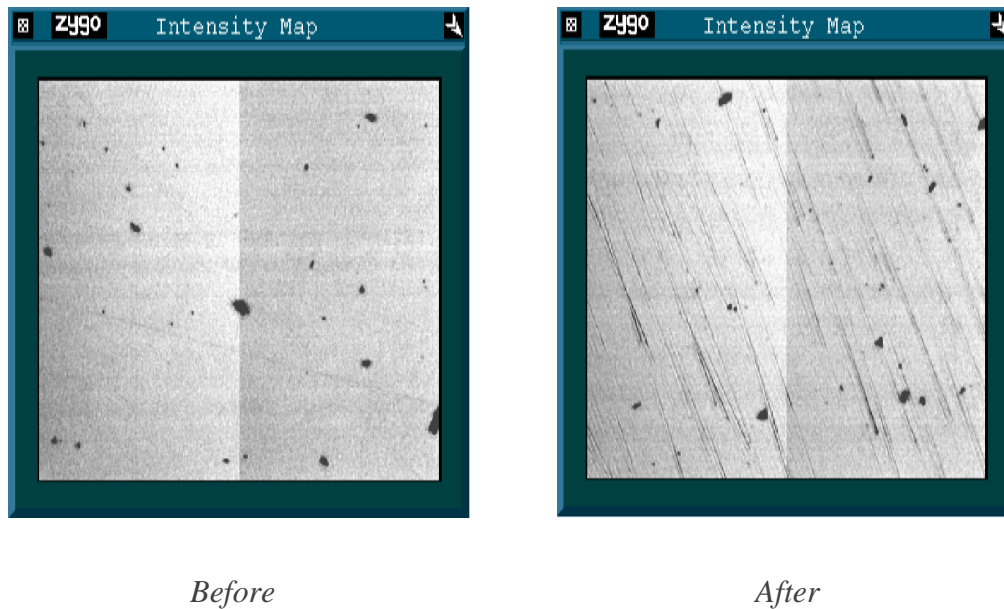
Figure 31: Intensity map collected from CoCr disc number 2 “Before” and “After” the pin on disc test. These maps have been collected in position 3 on the disc and so, on the wearing path.

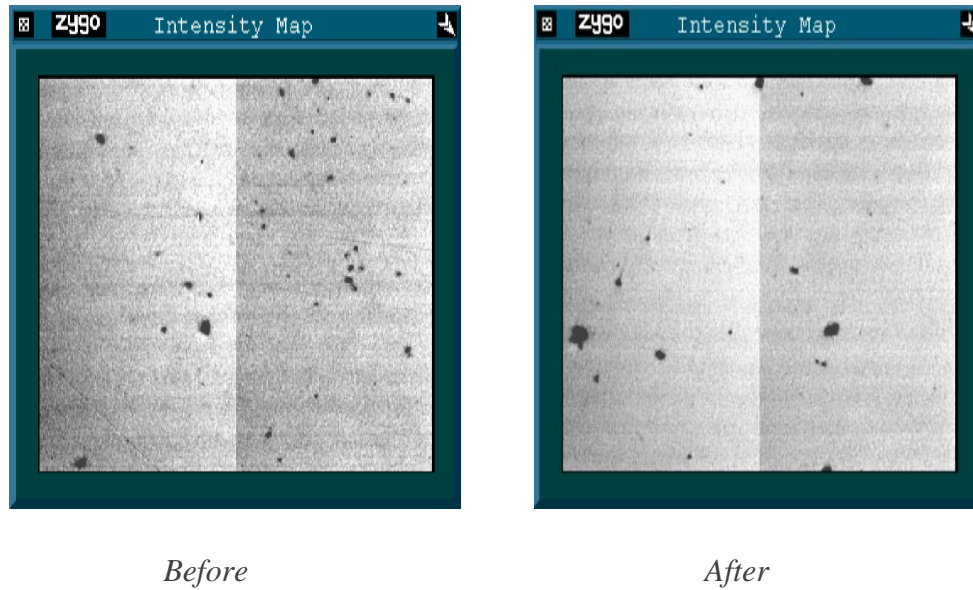
Figure 32: Intensity map collected from CoCr disc number 2 “Before” and “After” the pin on disc test. These maps have been collected in position 5 on the disc and so, on the unworn zone.

This point is not on the wearing path and so the metallic material is not in contact with the polymeric pin in point number five. This is why no major changes or scratches are visible in this area, even when observed at the microscopic level.

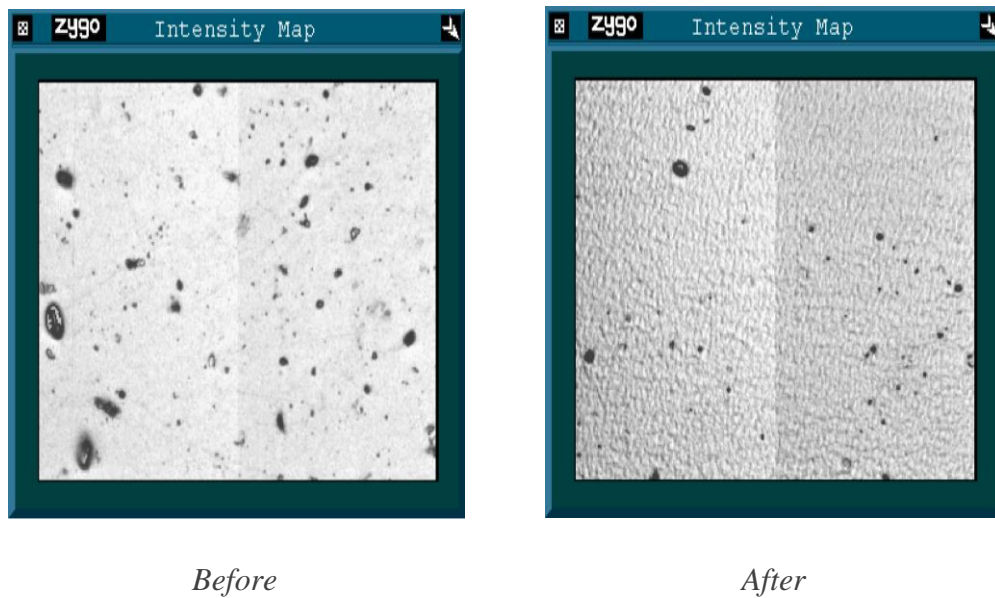
Figure 33: Intensity map collected from Tech #1 disc number 7 “Before” and “After” the pin on disc test. These maps have been collected in position 3 on the disc and so, on the wearing path.

Focusing on the disc coated with TiN deposited with Tech #1, it is evident how the layer deposited on the upper side of the disc has affected the surface characteristics. In fact, many more defects may be noticed on the surface that results in more rough. This is demonstrated also by the fact that the evaluated arithmetic surface for this type of discs is around 15-17nm as shown in TABLE XX.

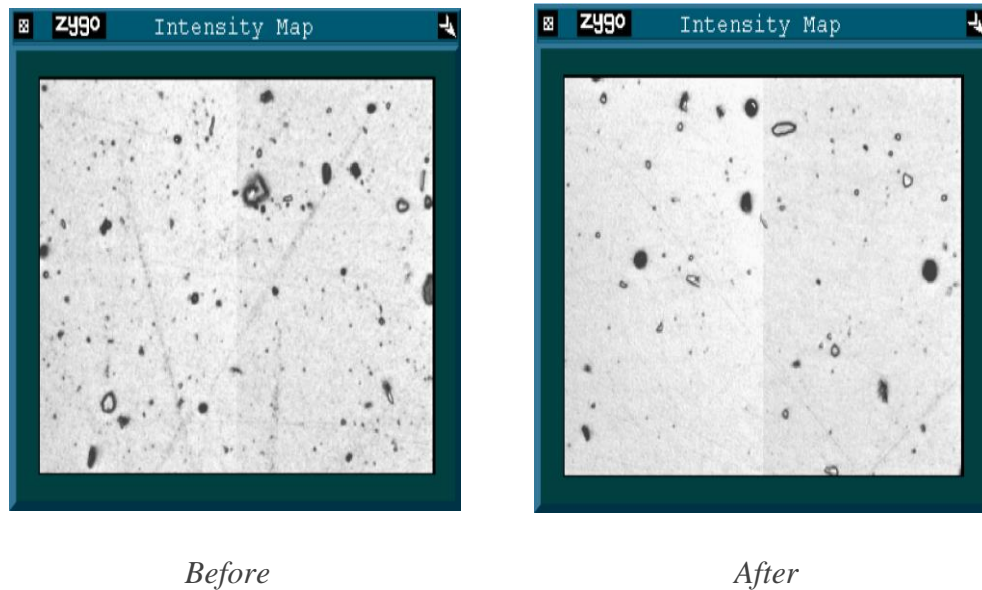
Figure 35: Intensity map collected from Tech #1 disc number 7 “Before” and “After” the pin on disc test. These maps have been collected in position 5 on the disc and so, on the unworn zone.

In order to assess the dependency between the change in surface characteristics and the performed pin on disc (POD) test, an intensity map image has been collected also from point five of the mask.

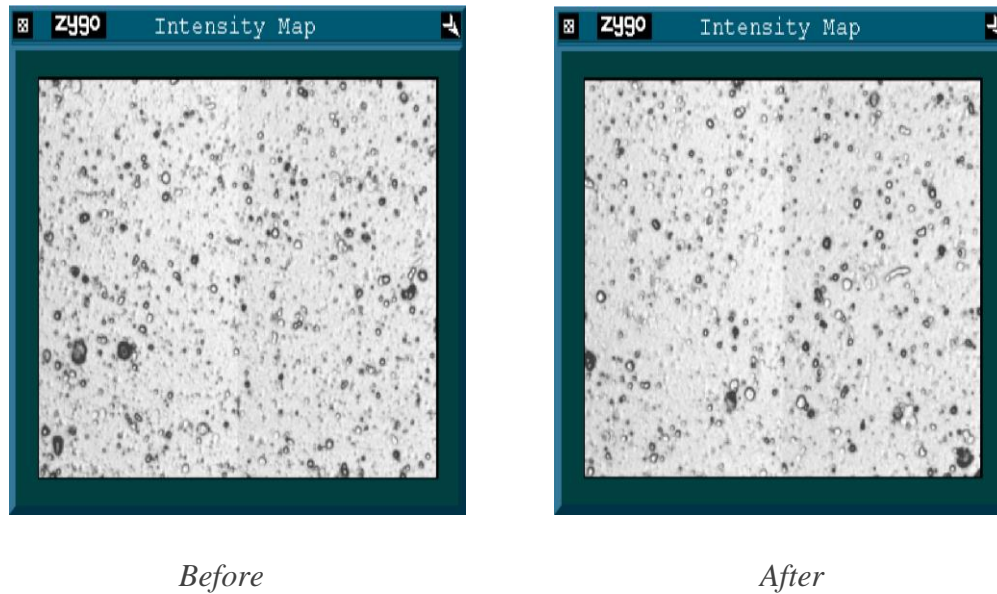
Figure 36: Intensity map collected from Tech #2 disc number 10 “Before” and “After” the pin on disc test. These maps have been collected in position 3 on the disc and so, on the wearing path.

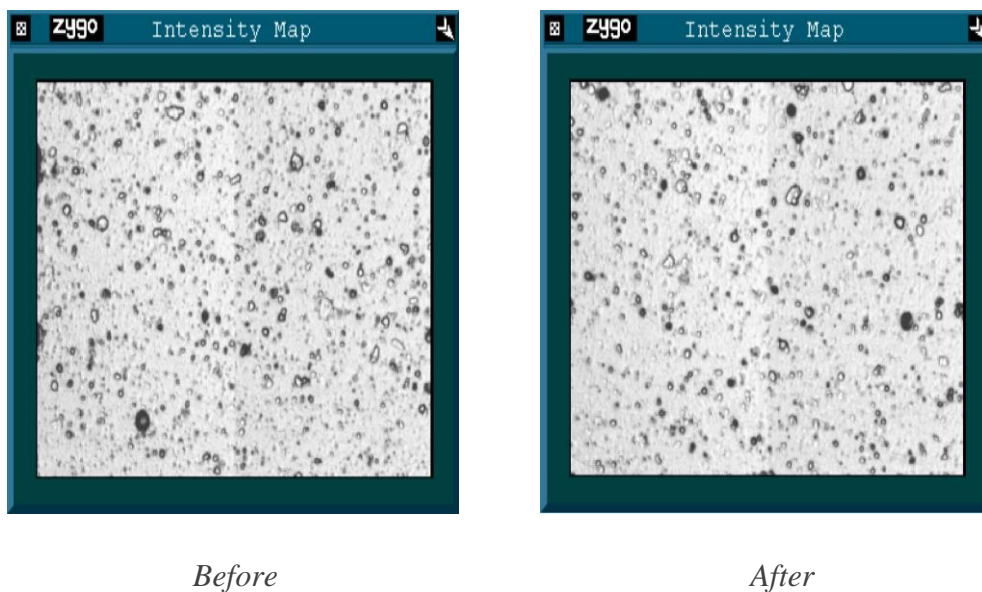
Figure 37: Intensity map collected from Tech #2 disc number 10 “Before” and “After” the pin on disc test. These maps have been collected in position 5 on the disc and so, on the unworn zone.

This eye appearance has been confirmed also by the microscopic analysis that has been performed using Zygo microscope. In fact, when focusing the attention on the microscopic characteristics of the damaged area, here represented in the Intensity maps collected from point number three of the mask reported in the previous page, it has been noticed no visible changes in the surface characteristics.

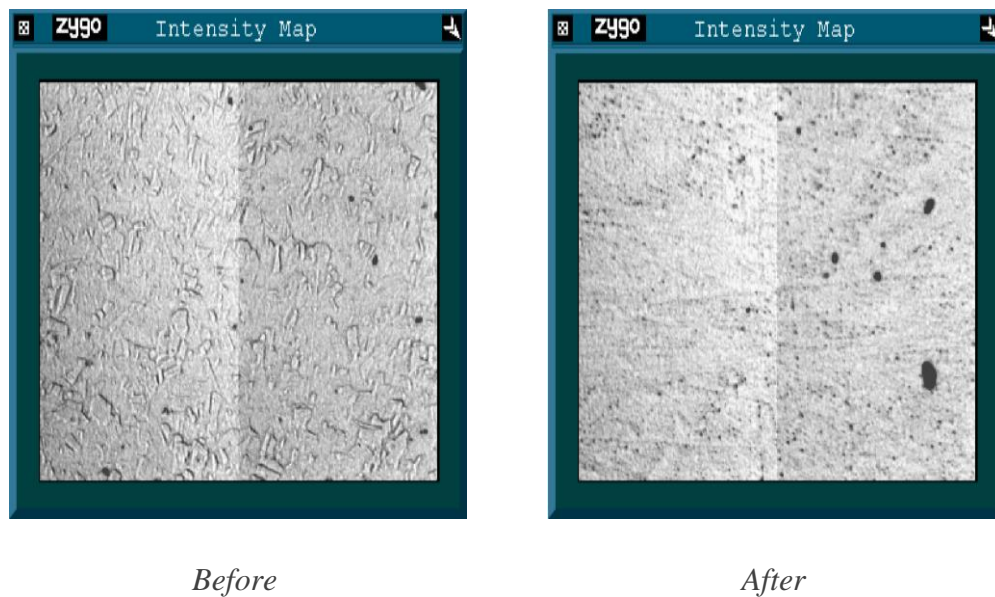
Figure 38: Intensity map collected from Tech #3 disc number 13 “Before” and “After” the pin on disc test. These maps have been collected in position 3 on the disc and so, on the wearing path.

Considering, now, the discs coated with process number 3, the surface of these materials show a visible difference in respect to the one seen for the other coating processes. Defects are less and a particular pattern is visible on the layer covering the bulk CoCr disc. This is responsible also for the value of arithmetic roughness showed in TABLE XX that is well around 13-14 nm. Moreover, by eye-comparing the “Before” disc with the “After” disc, the pin on disc (POD) test, only minor changes are the visible characteristics of the surface of the material.

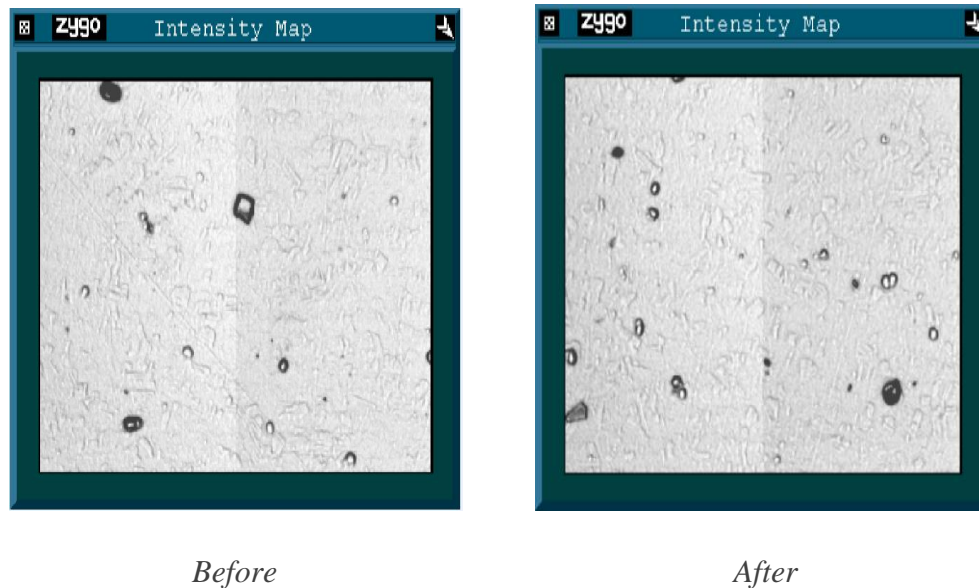
Figure 39: Intensity map collected from Tech #3 disc number 14 “Before” and “After” the pin on disc test. These maps have been collected in position 5 on the disc and so, on the unworn zone.

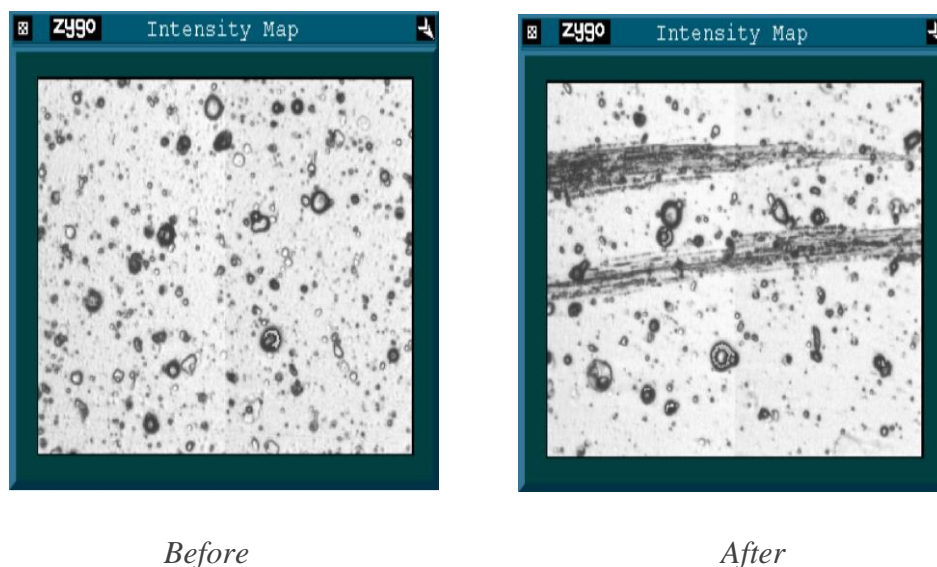
Figure 40: Intensity map collected from AgTiN coated disc number 18 “Before” and “After” the pin on disc test. These maps have been collected in position 1 on the wearing path.

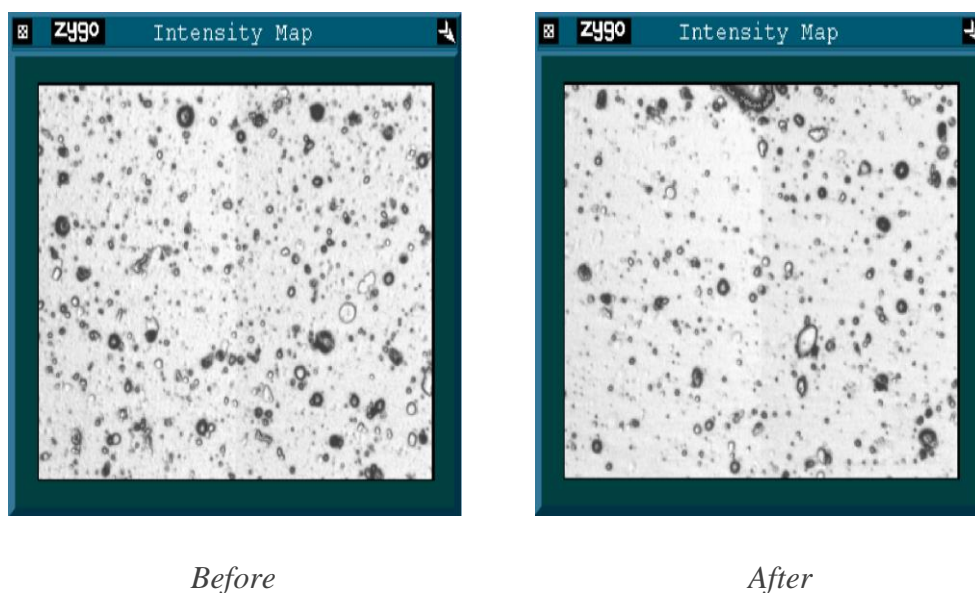
Figure 41: Intensity map collected from AgTiN coated disc number 18 “Before” and “After” the pin on disc test. These maps have been collected in position 5 on the disc and so, on the unworn zone.

This point is not on the wearing path and so the metallic material is not in contact with the polymeric in point number five. This is why no major changes or scratches are visible in this area, even when observed at the microscopic level.

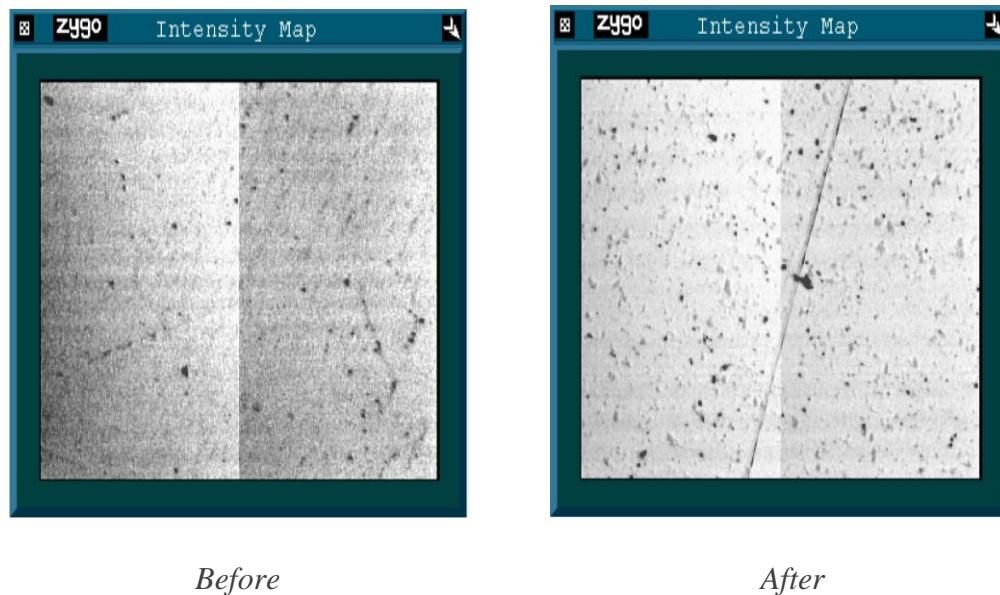
Figure 42: Intensity map collected from CoCr disc from the LAB number 23 “Before” and “After” the pin on disc test. These maps have been collected in position 2 on the disc and so, on the wearing path.

However, when focusing the attention on the microscopic characteristics of the damaged area, here represented in the Intensity maps collected from point number two of the mask, it has been noticed the presence of some long scratches oriented as the direction of movement of the pin on the surface itself.

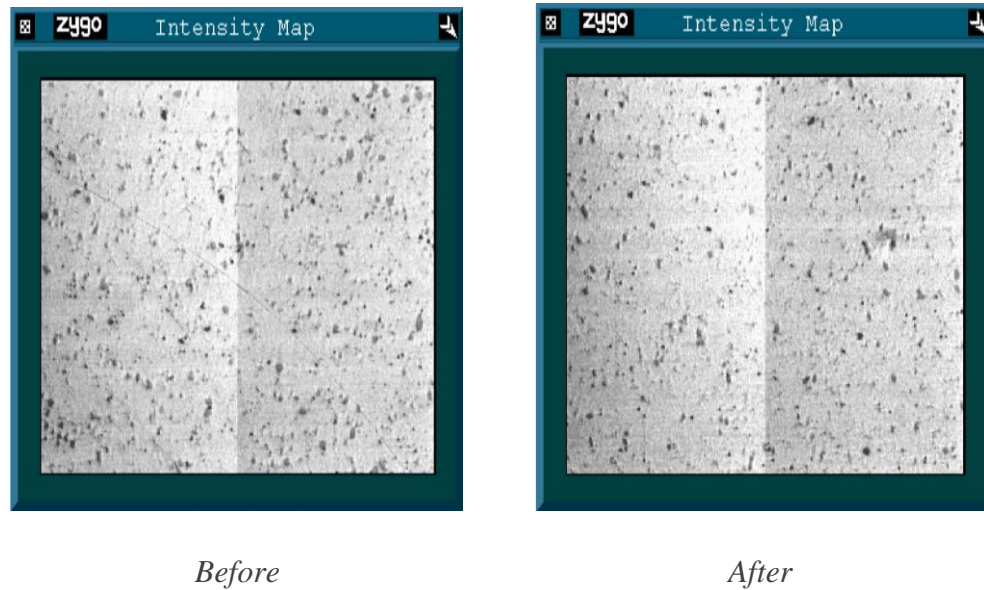
Figure 43: Intensity map collected from CoCr disc from the LAB number 23 “Before” and “After” the pin on disc test. These maps have been collected in position 5 on the disc and so, on the unworn zone.

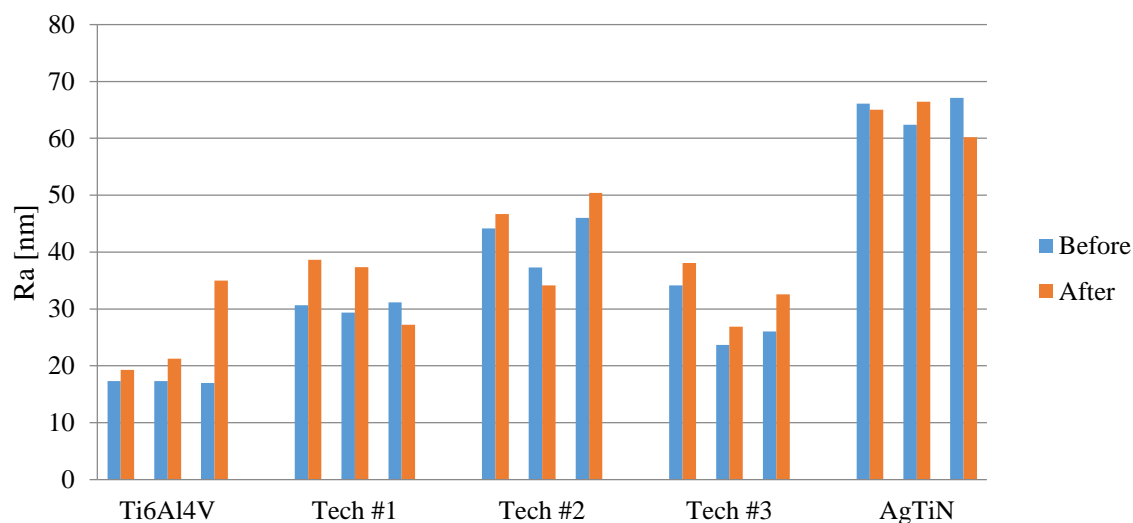
Figure 44: Summary of the arithmetic roughness for Ti6Al4V test. All the values of Ra, collected "Before" and "After" the pin on disc (POD) test, are subdivided into disc type groups and shown in nm.

Hereunder, a bar chart that illustrates all the variations in the surface roughness of the different discs has been reported. Moreover, a final summary of the value of the surface roughness Ra, obtained as the average value of the three measurements that have been performed, has been reported for each disc type.

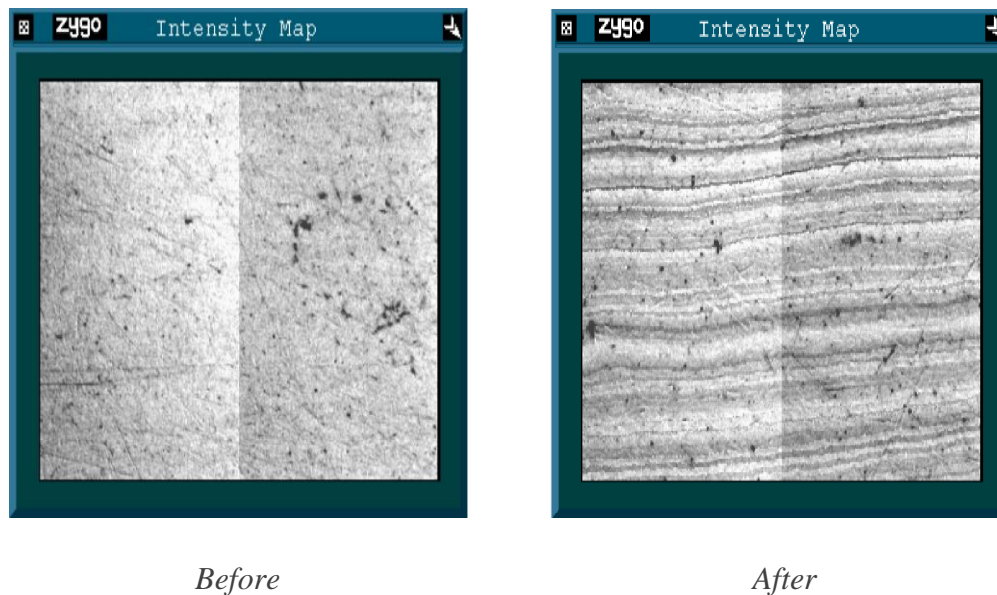
Figure 45: Intensity map collected from Ti6Al4V disc number 25 “Before” and “After” the pin on disc test. These maps have been collected in position 3 on the disc and so, on the wearing path.

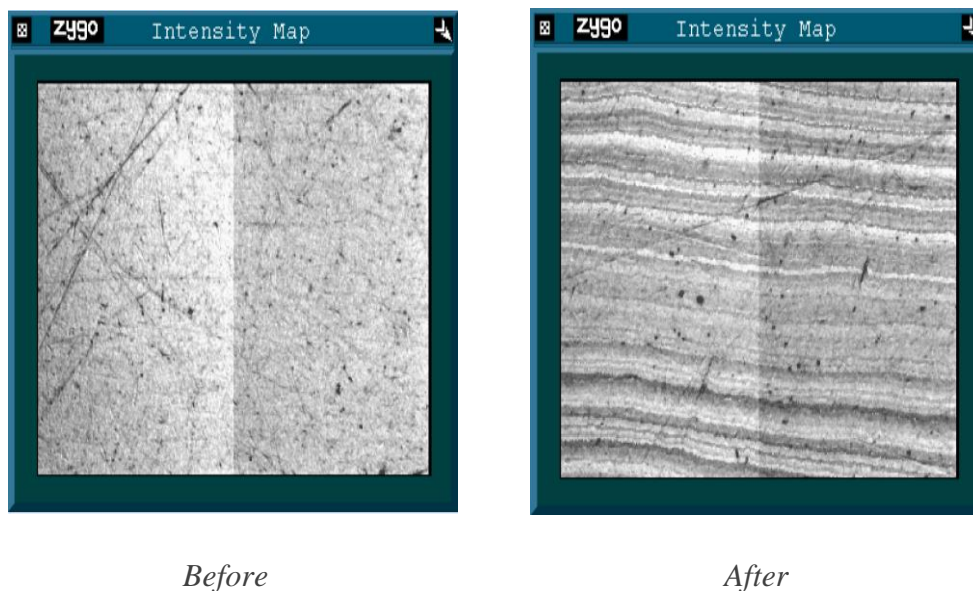
Figure 46: Intensity map collected from Ti6Al4V disc number 25 “Before” and “After” the pin on disc test. These maps have been collected in position 5 on the disc and so, on the unworn zone.

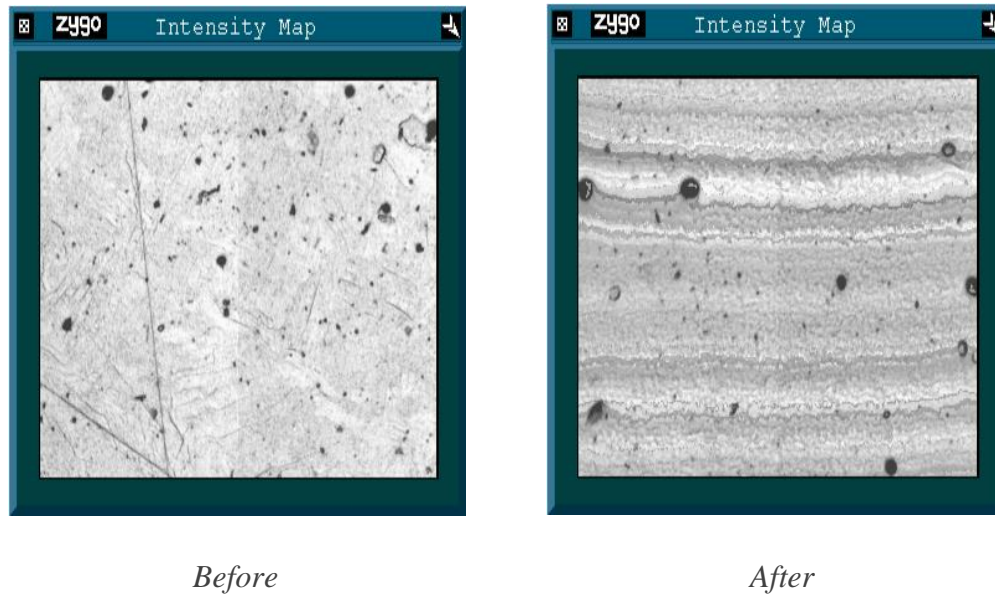
Figure 47: Intensity map collected from Tech #1 disc number 29 “Before” and “After” the pin on disc test. These maps have been collected in position 3 on the disc and so, on the wearing path.

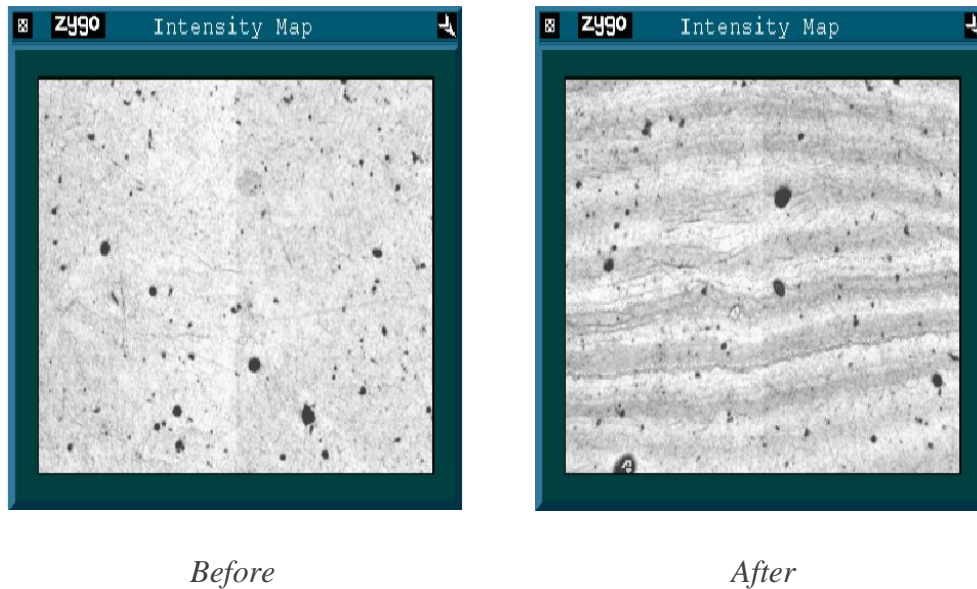
Figure 48: Intensity map collected from Tech #1 disc number 29 “Before” and “After” the pin on disc test. These maps have been collected in position 5 on the disc and so, on the unworn zone.

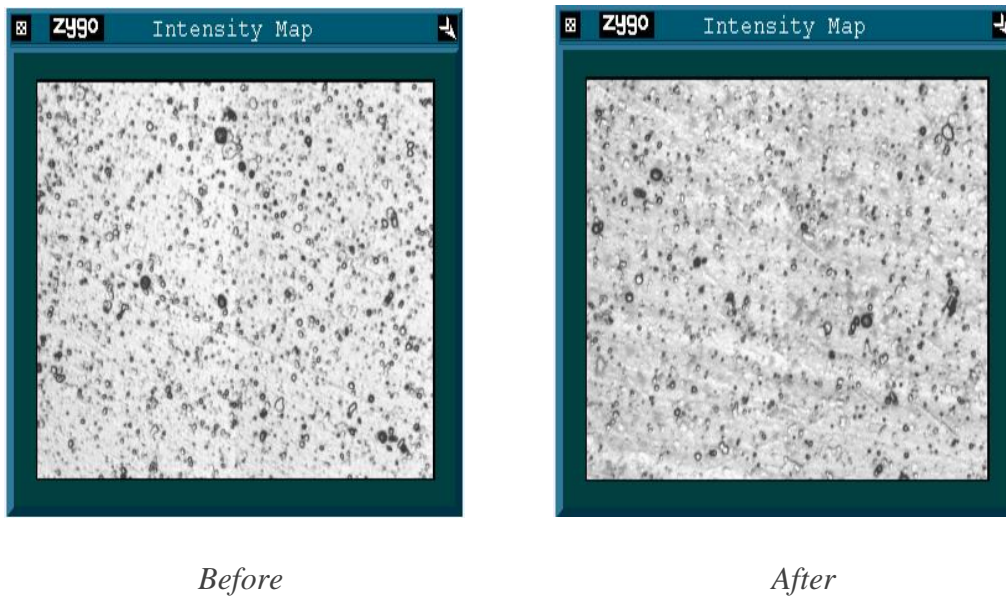
Figure 49: Intensity map collected from Tech #2 disc number 33 “Before” and “After” the pin on disc test. These maps have been collected in position 3 on the disc and so, on the wearing path.

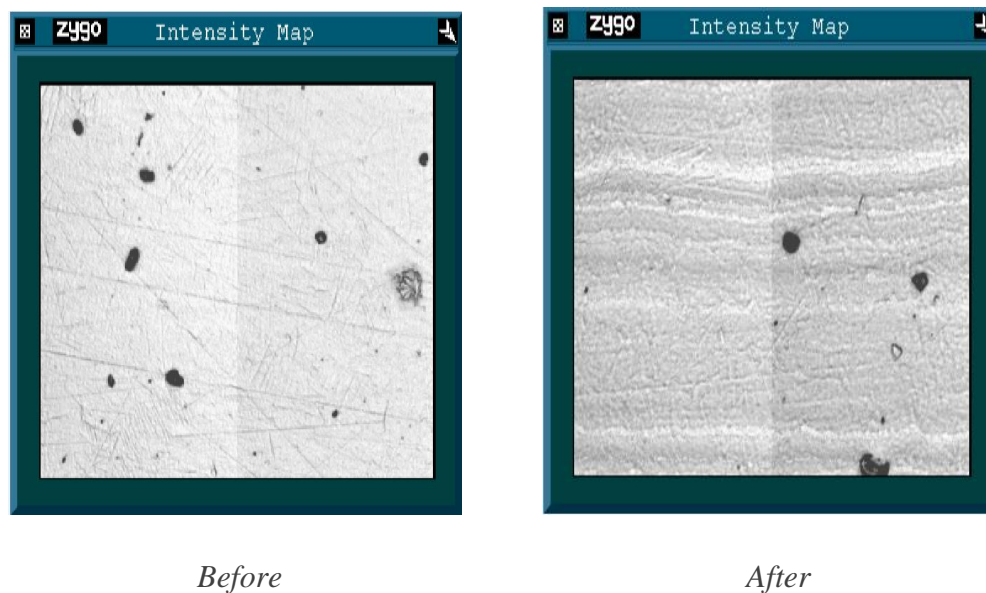
Figure 51: Intensity map collected from Tech #3 disc number 37 “Before” and “After” the pin on disc test. These maps have been collected in position 3 on the disc and so, on the wearing path.

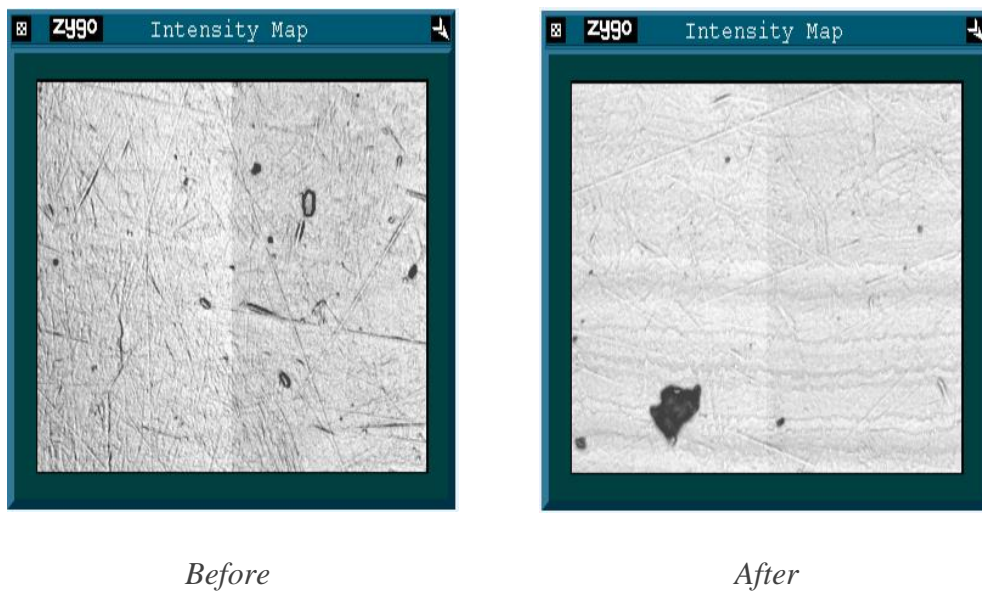
Figure 52: Intensity map collected from Tech #3 disc number 37 “Before” and “After” the pin on disc test. These maps have been collected in position 5 on the disc and so, on the unworn zone.

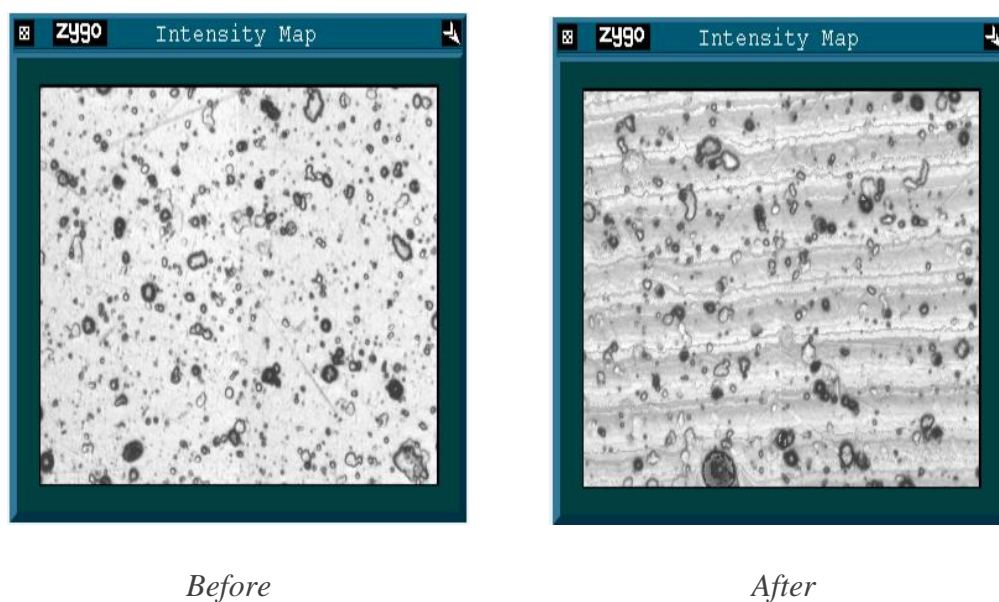
Figure 53: Intensity map collected from AgTiN coated disc number 41 “Before” and “After” the pin on disc test. These maps have been collected in position 1 on the wearing path.

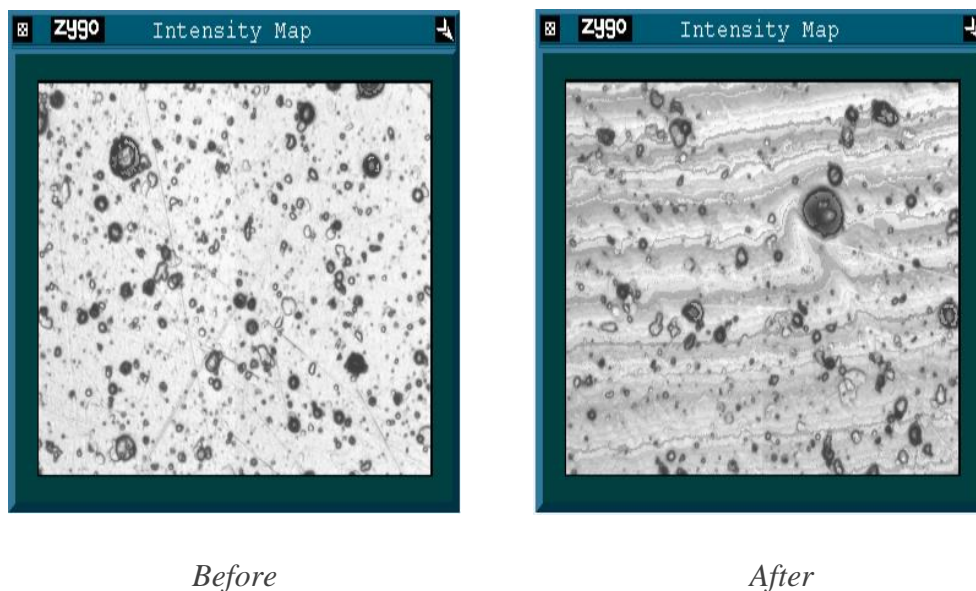
Figure 54: Intensity map collected from AgTiN coated disc number 41 "Before" and "After" the pin on disc test. These maps have been collected in position 5 on the unworn zone.

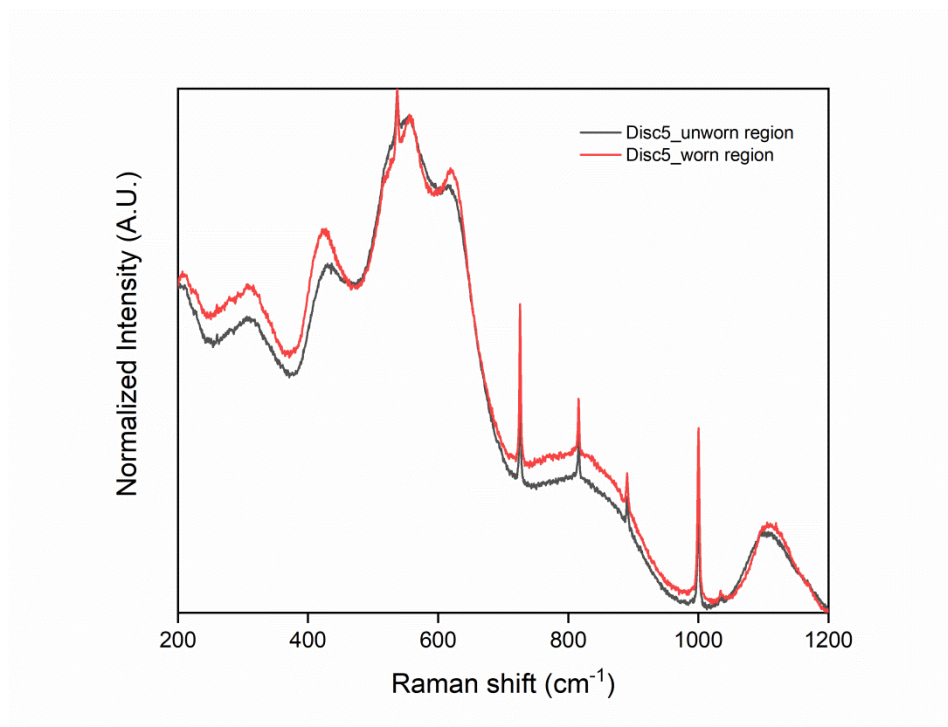
Figure 57: Raman spectroscopy for tech #1 coated disc number 5 ¹⁰.

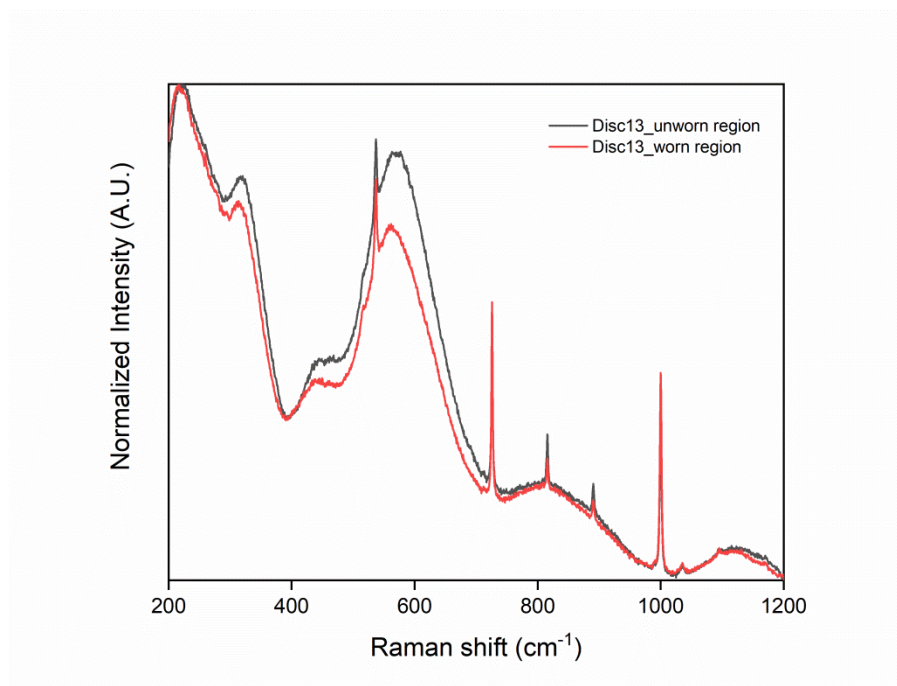
Figure 59, Raman spectroscopy for Tech #3 coated disc number 13 ¹².

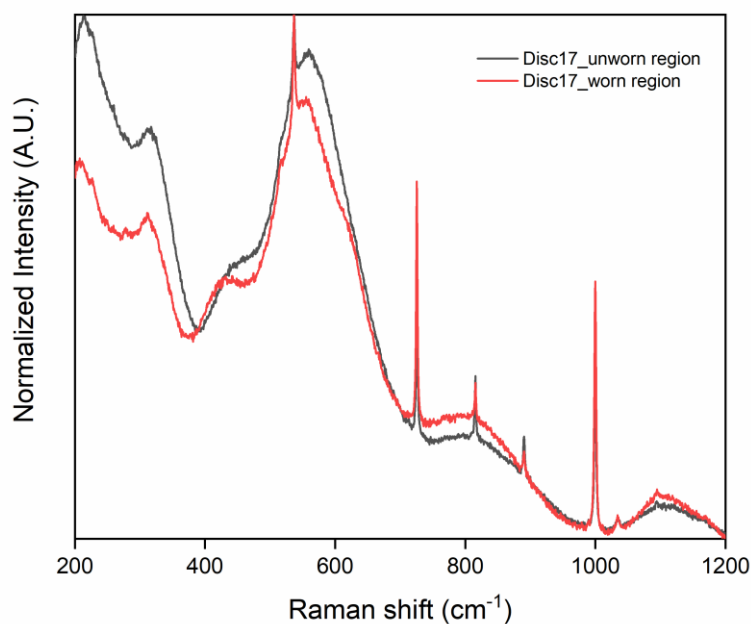
Figure 60: Raman spectroscopy for AgTiN coated disc number 17 ¹³.

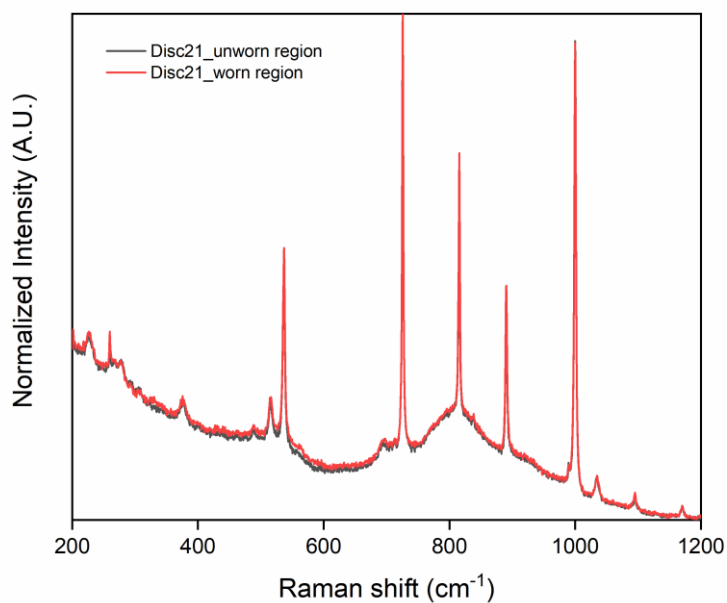
Figure 61: Raman spectroscopy for CoCr uncoated disc from the lab number 21¹⁴.

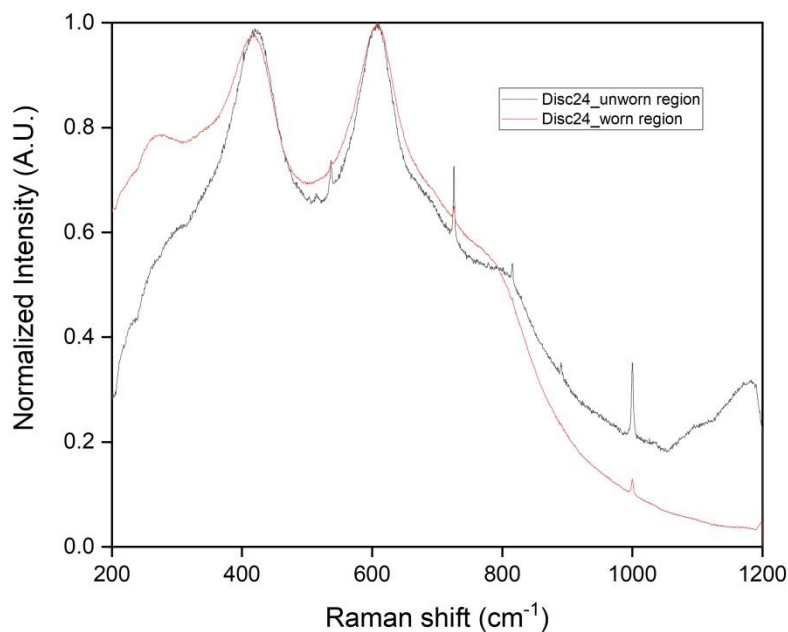
Figure 62: Raman spectroscopy for Ti6Al4V uncoated disc number 24 ¹⁵.

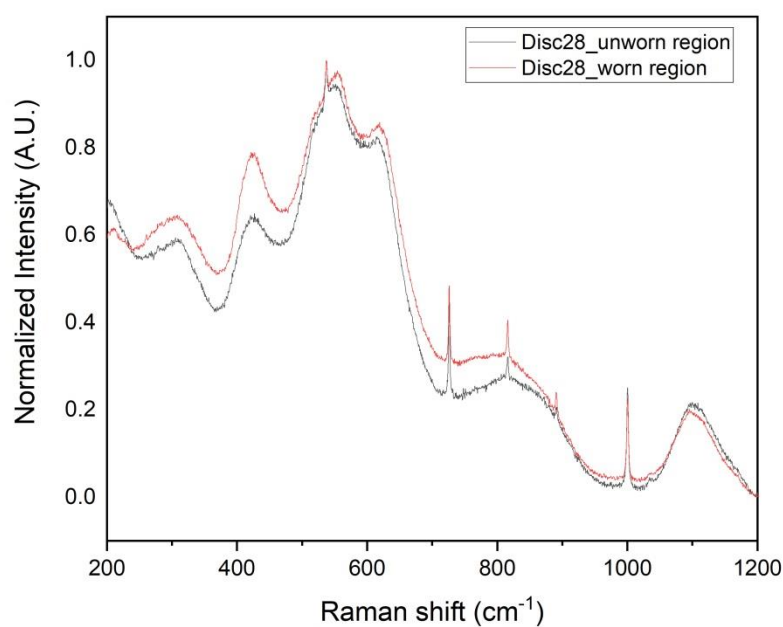
Figure 63: Raman spectroscopy for Tech #1 coated disc number 28 ¹⁶.

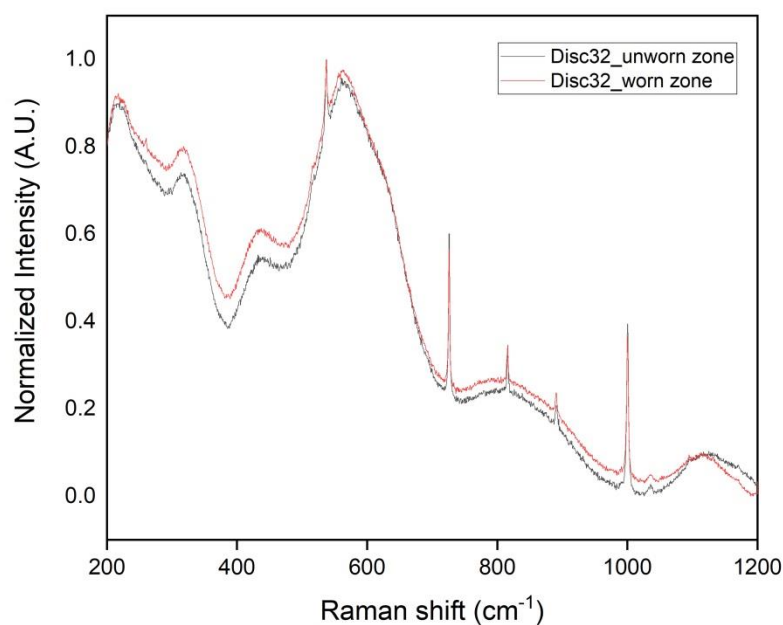
Figure 64: Raman spectroscopy for Tech #2 coated disc number 32 ¹⁷.

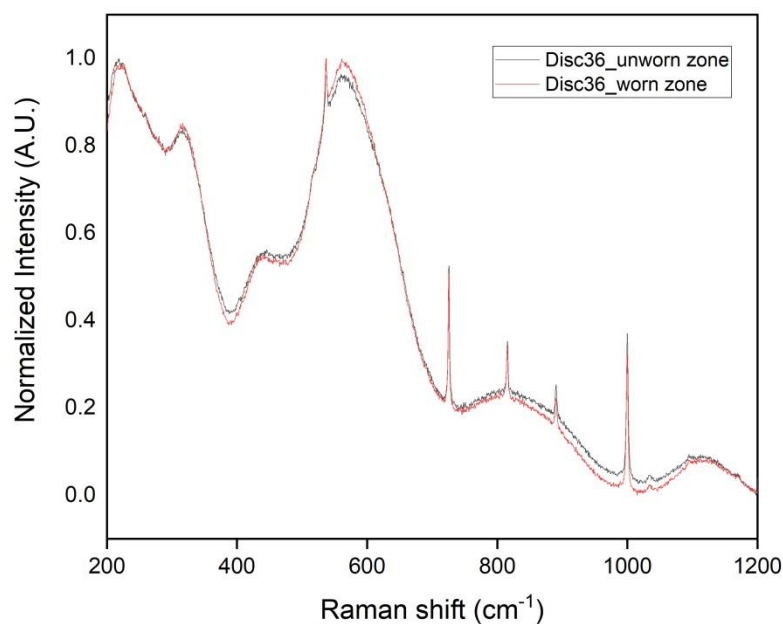
Figure 65, Raman spectroscopy for Tech #3 coated disc number 36 ¹⁸.

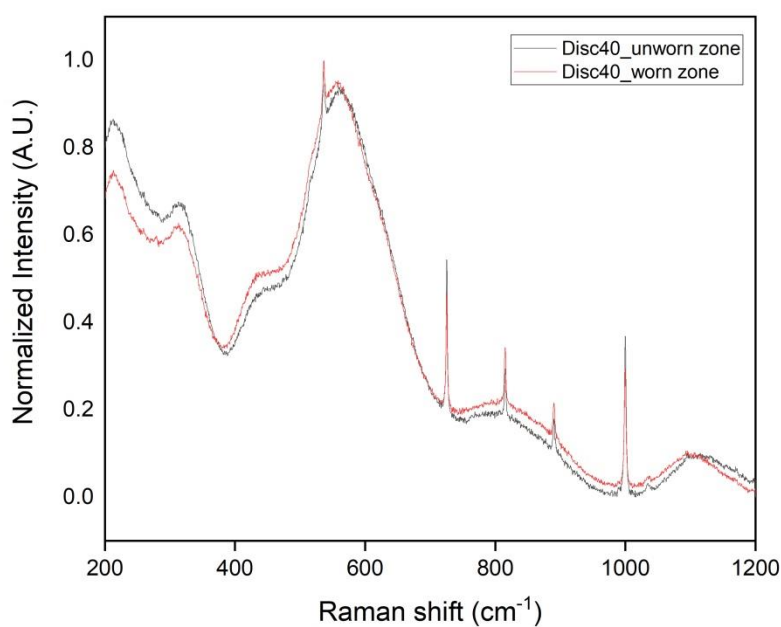
Figure 66: Raman spectroscopy for AgTiN coated disc number 40 ¹⁹.

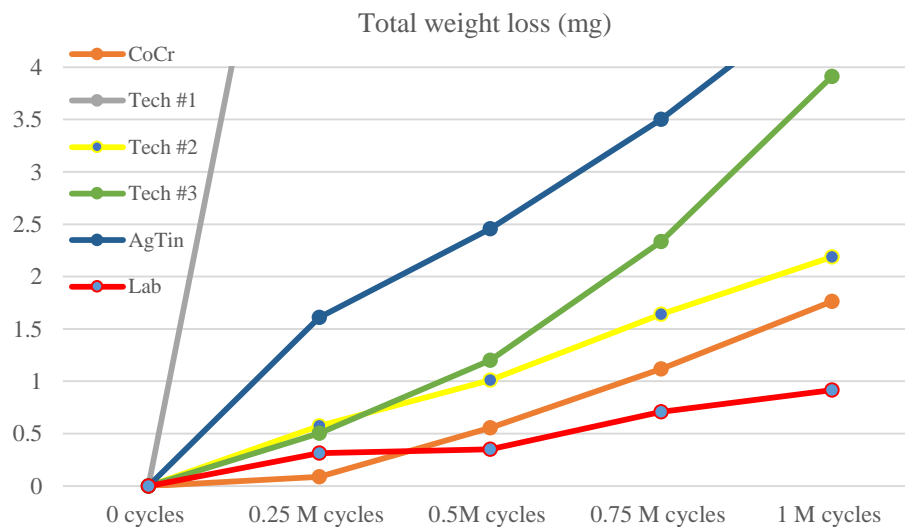
Figure 79: Total weight loss for Round 1 of CoCr test ²⁰.

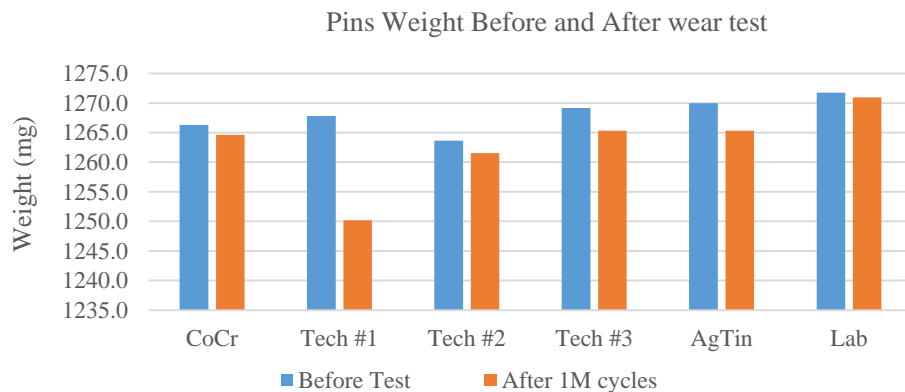
Figure 81: Pin weight “Before test” and “After 1M cycles” for Round 1, CoCr test.

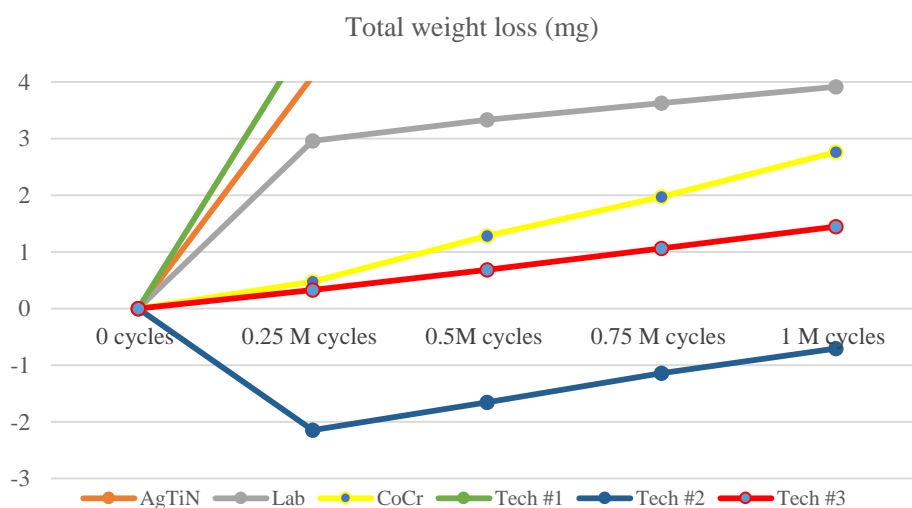
Figure 83: Total weight loss for Round 2 of CoCr test ²².
