Wear Behavior Of Polyethylene Against Titanium Nitride Coated Alloy Surfaces For Joint Replacement

THESIS

Submitted as partial fulfillment of the requirements
for the degree of Master of Science in Bioengineering
in the Graduate College of the
University of Illinois at Chicago, 2020

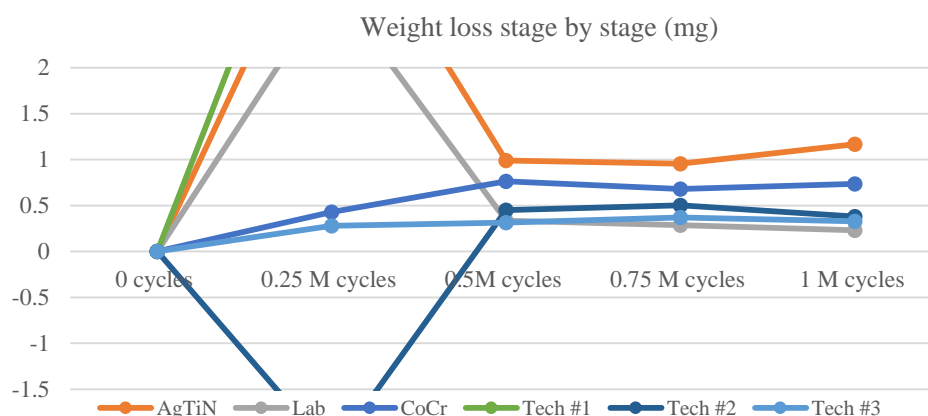
Figure 84: weight loss measured stage by stage for Round 2 of CoCr test ²³.

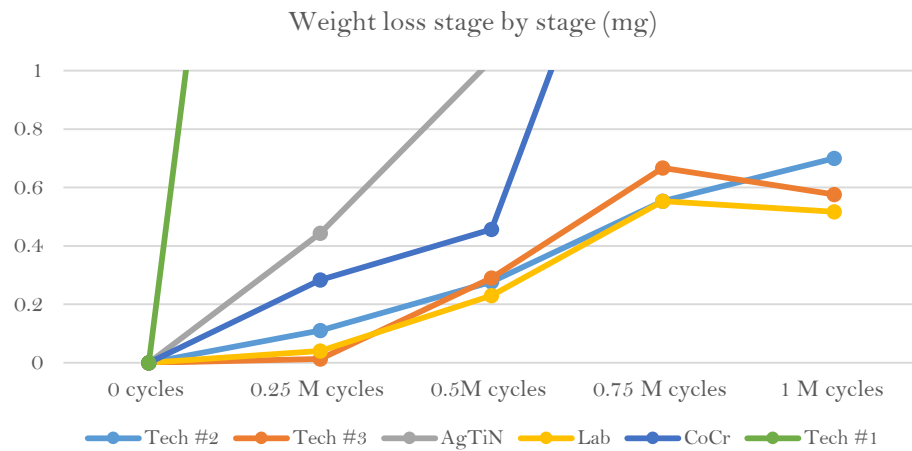
Figure 88: weight loss measured stage by stage for Round 3 of CoCr test ²⁵.

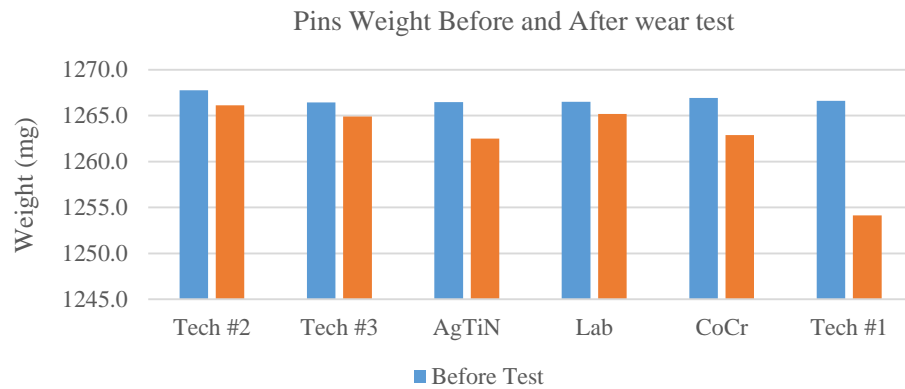
Figure 89: Pin weight “Before test” and “After 1M cycles” for Round 3, CoCr test.

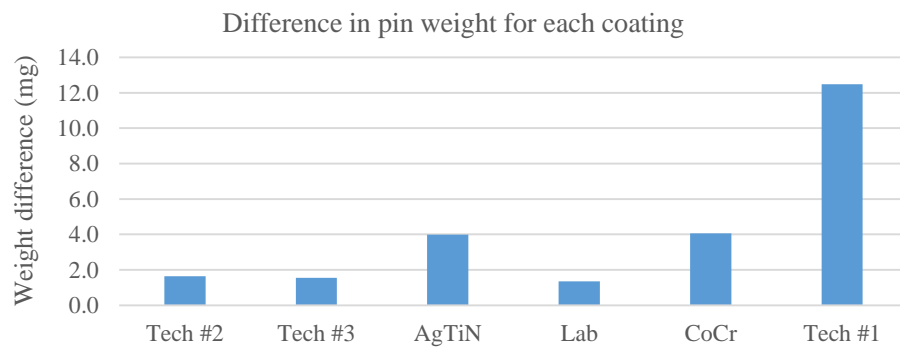
Figure 90: Final difference of weight for each pin for Round 3, CoCr test.

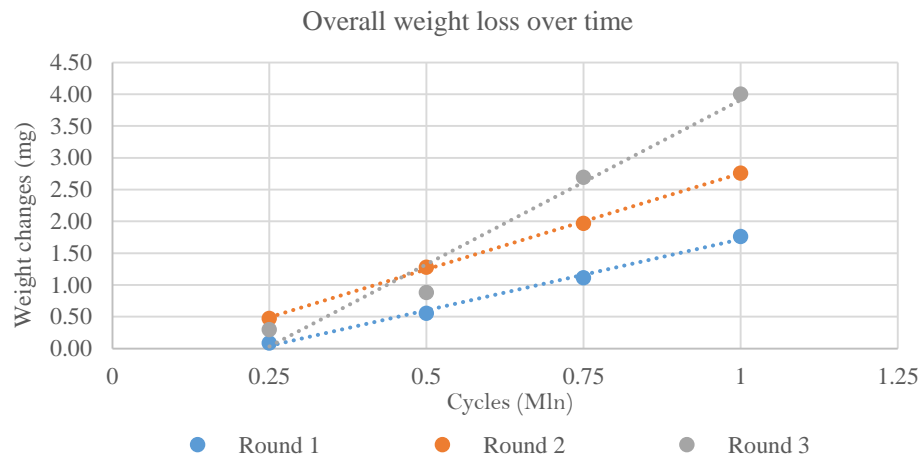
Figure 91: Interpolation curve of the debris production data from POD test on CoCr disc.

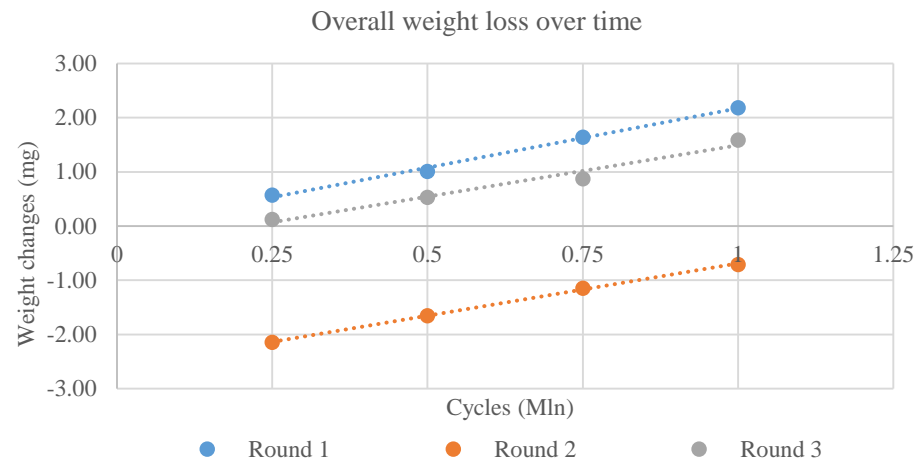
Figure 93: Interpolation curve of the debris production data from POD test on Tech #2 disc.

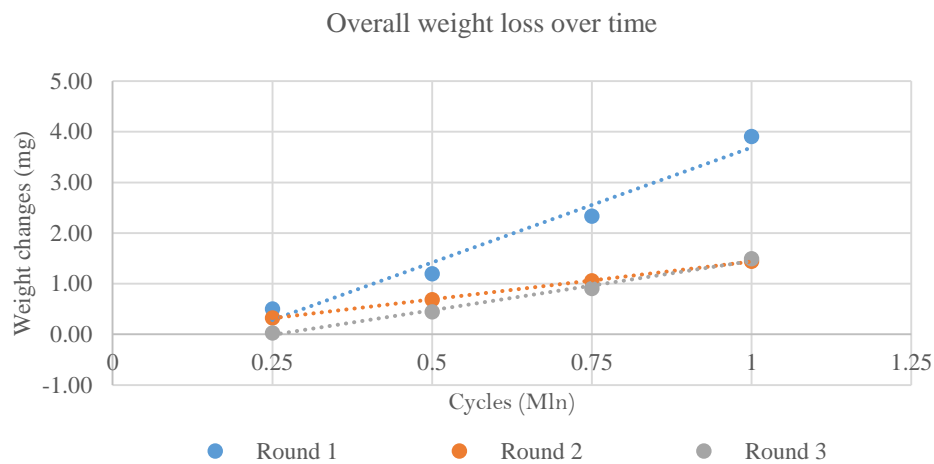
Figure 94: Interpolation curve of the debris production data from POD test on Tech #3 disc.

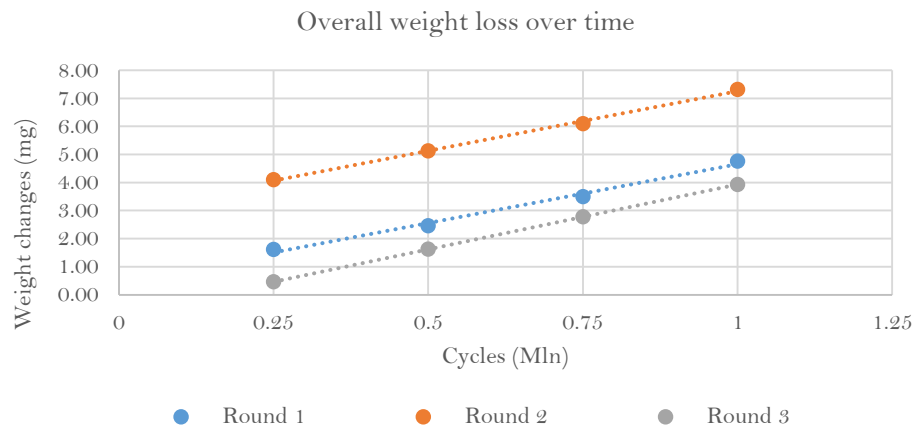
Figure 95: Interpolation curve of the debris production data from POD test on AgTiN disc.

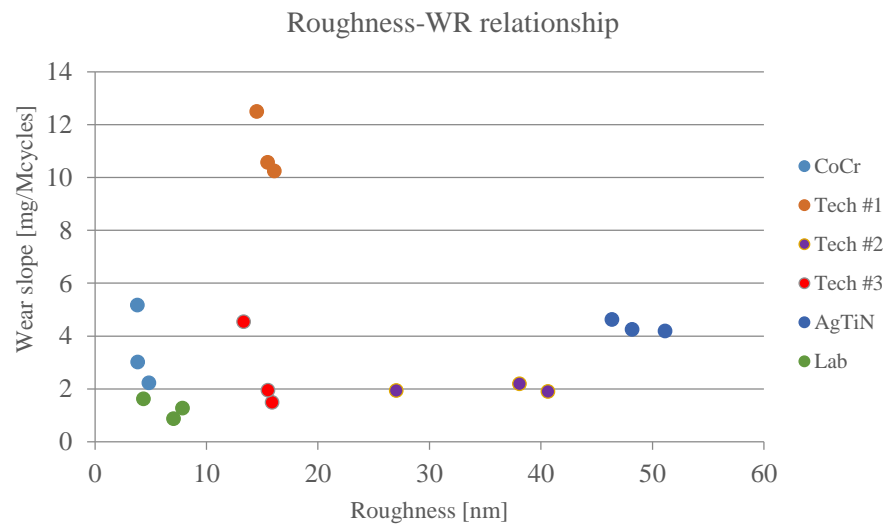
Roughness-Wearing rate dependency

Figure 97: Roughness-Wearing rate relationship graph.

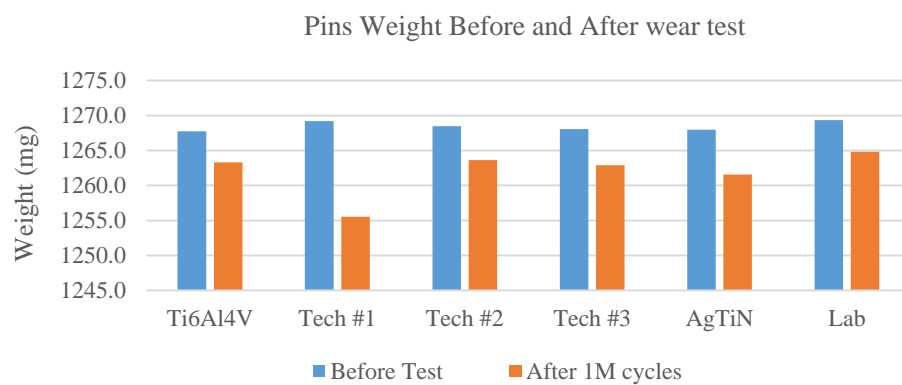
Figure 100: Pin weight “Before test” and “After 1M cycles” for Round 1, Ti6Al4V test.

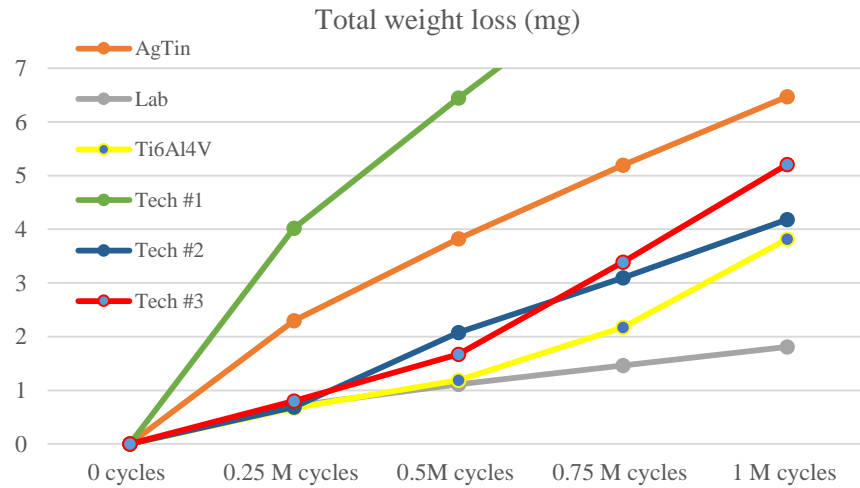
Figure 102: Total weight loss for Round 2 of Ti6Al4V test ²⁷.

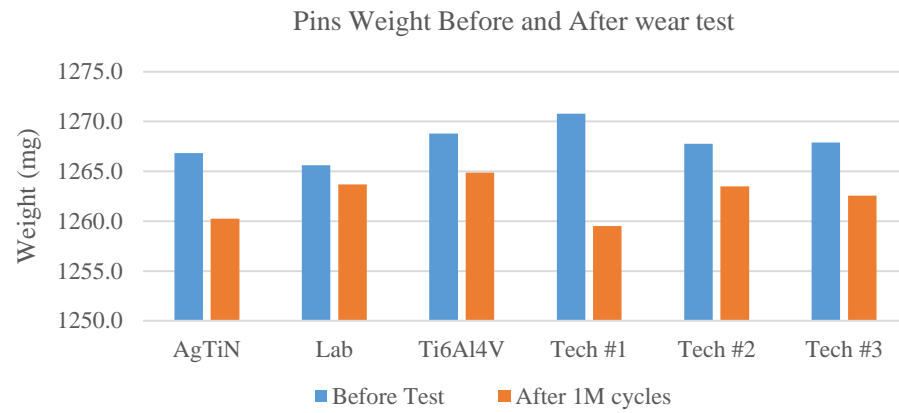
Figure 104: Pin weight at “Before test” cycles and “After 1M cycles” for Round 2, Ti6Al4V test.

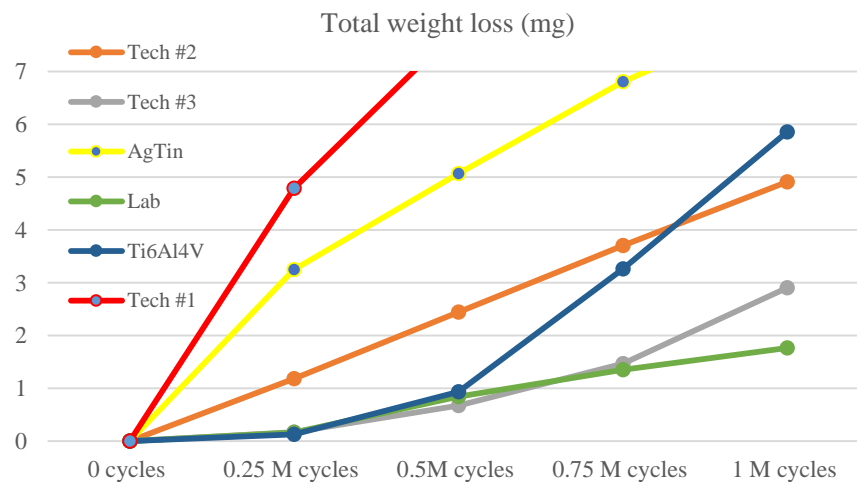
Figure 106: Total weight loss for Round 3 of Ti6Al4V test ²⁸.

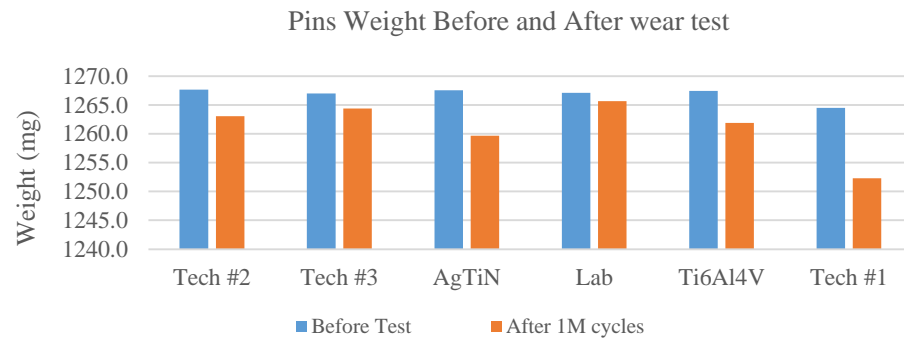
Figure 108: Pin weight “Before test” and “After 1M cycles” for Round 3, Ti6Al4V test.

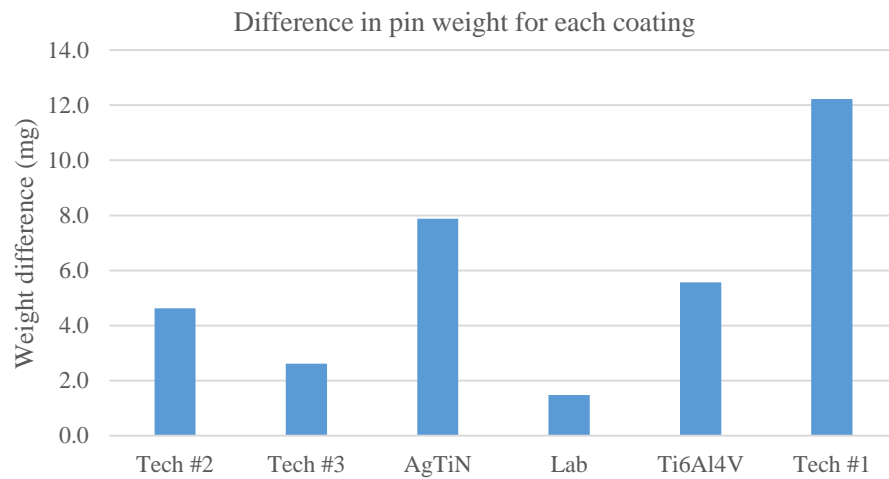
Figure 109: Final difference of weight for each pin for Round 3, Ti6Al4V test.

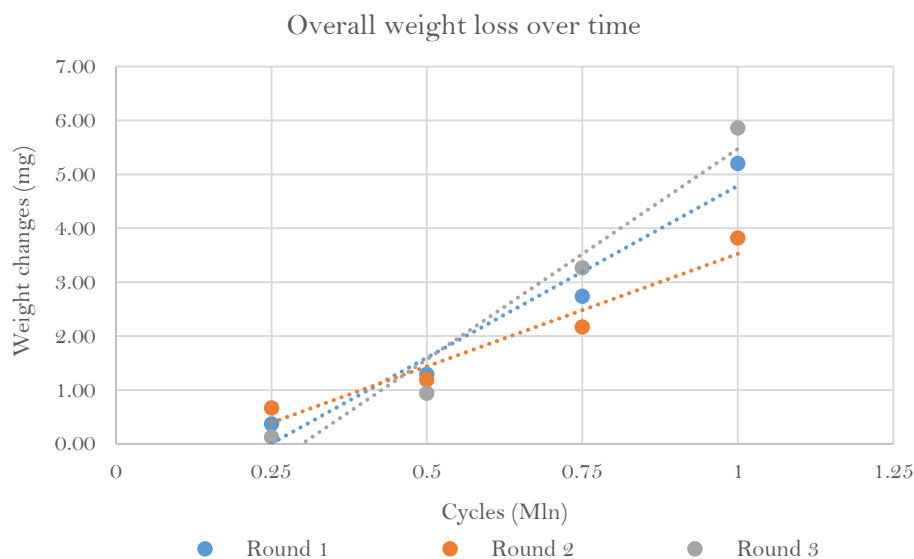
Figure 110: Interpolation curve of the debris production data from POD test on Ti6Al4V disc.

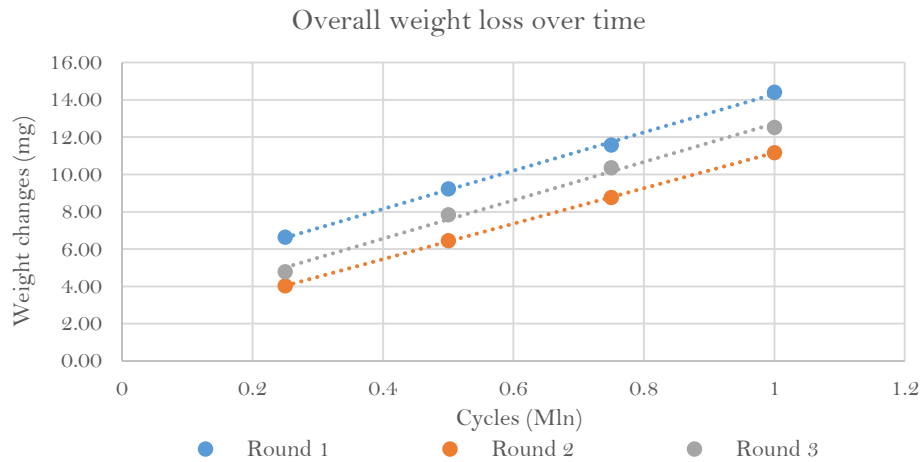
Figure 111: Interpolation curve of the debris production data from POD test on Tech #1 disc.

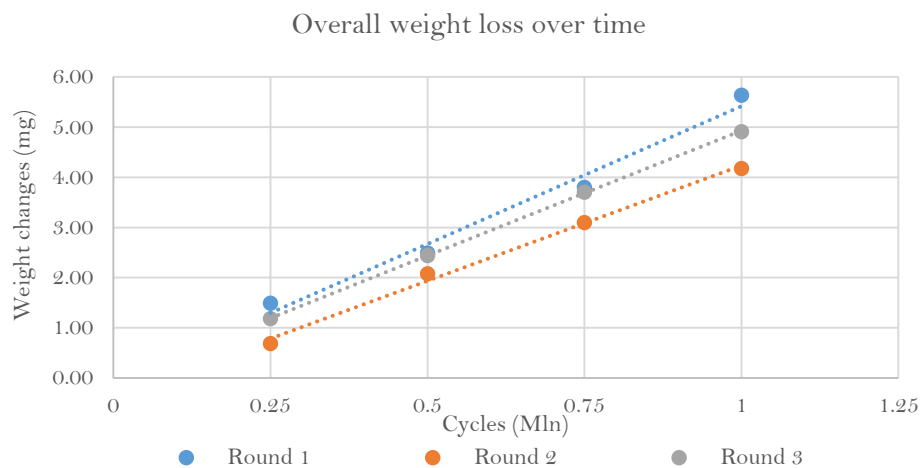
Figure 112: Interpolation curve of the debris production data from POD test on Tech #2 disc.

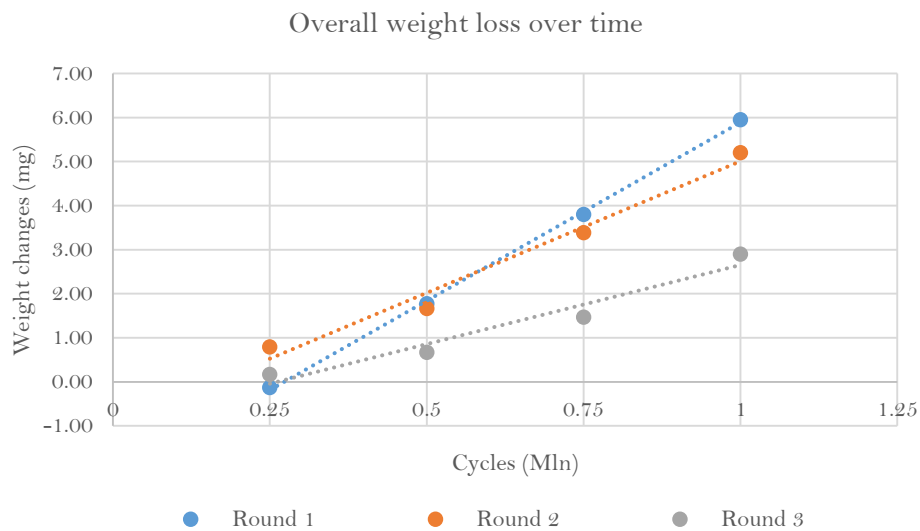
Figure 113: Interpolation curve of the debris production data from POD test on Tech #3 disc.

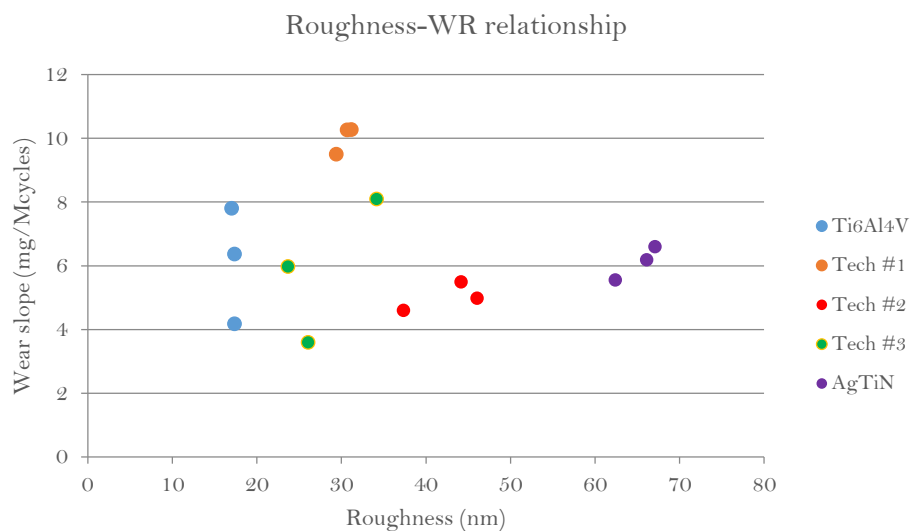
Figure 115: Roughness-wearing rate dependency.

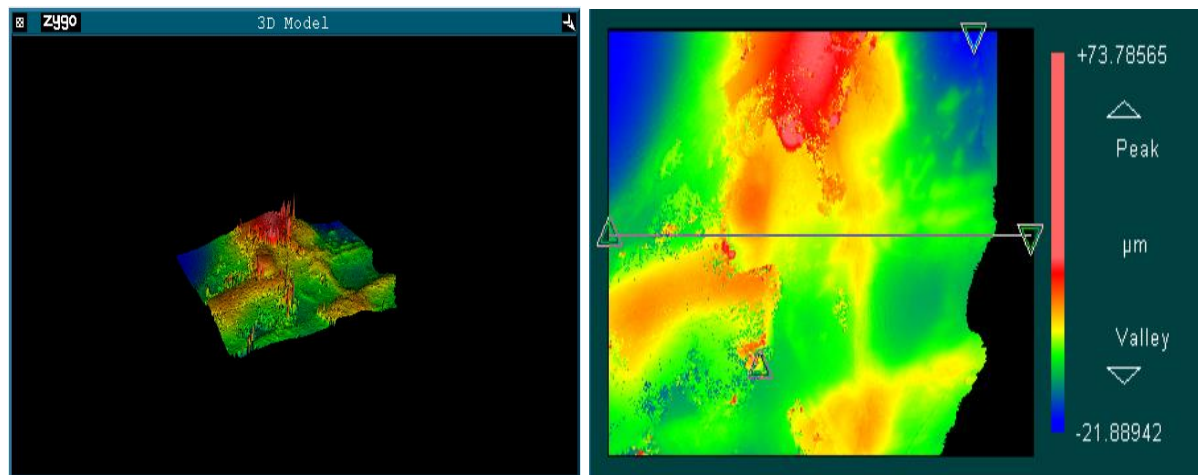
Figure 129: Picture that grouped the 3D model and the Surface map of the contact surface of the pin OE11.

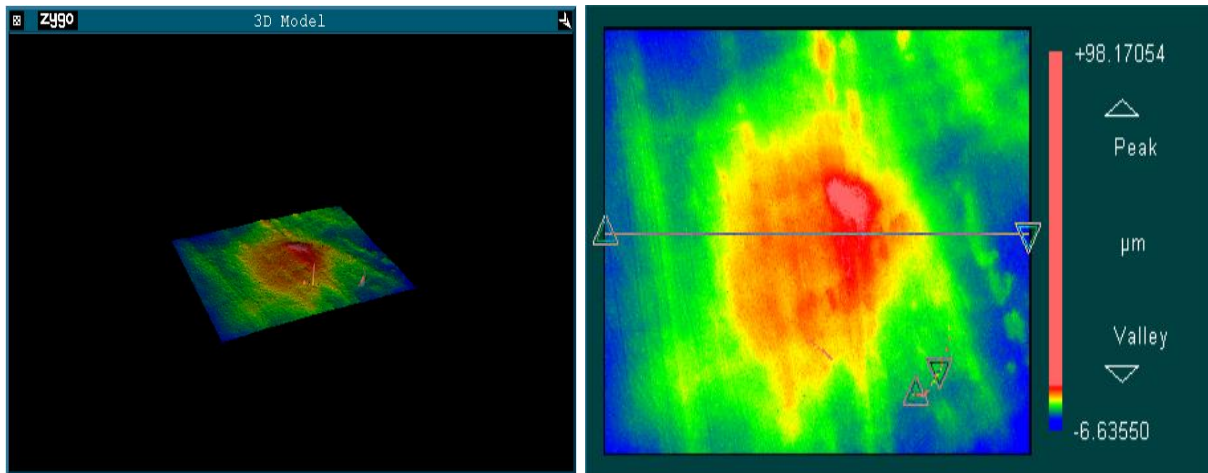
Figure 132: Picture that grouped the 3D model and the Surface map of the contact surface of the pin OE8.

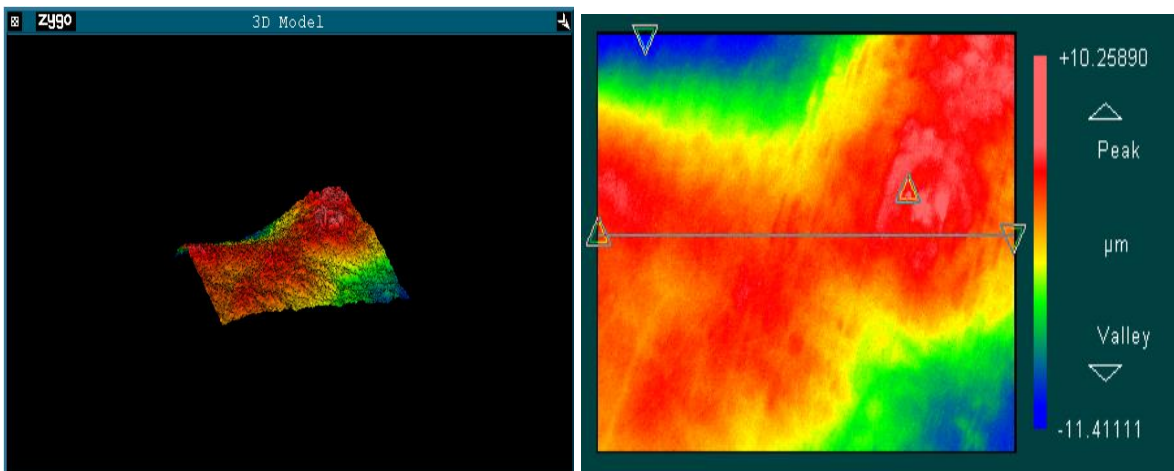
Figure 134, Picture that grouped the 3D model and the Surface map of the contact surface of the pin OE22.

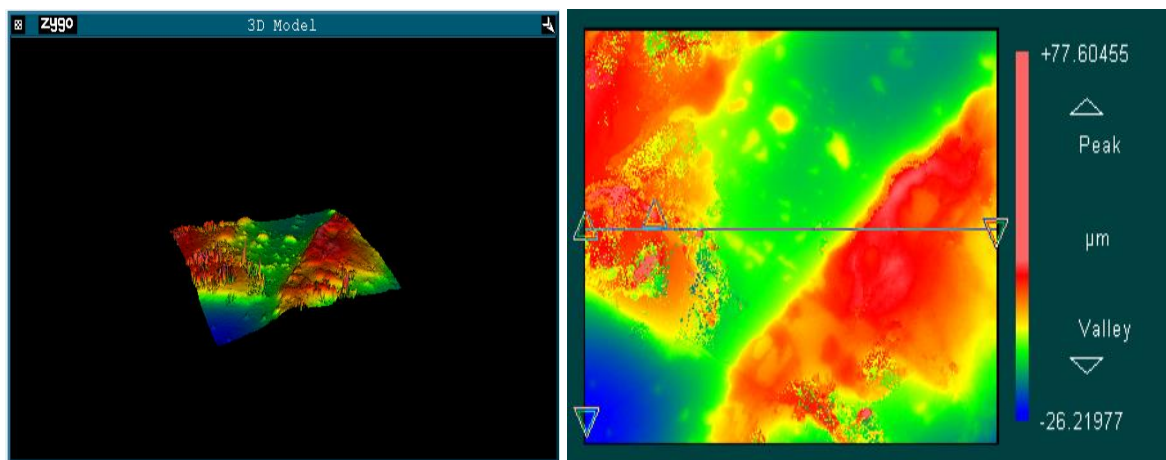
Figure 135: Picture that grouped the 3D model and the Surface map of the contact surface of the pin OE23.

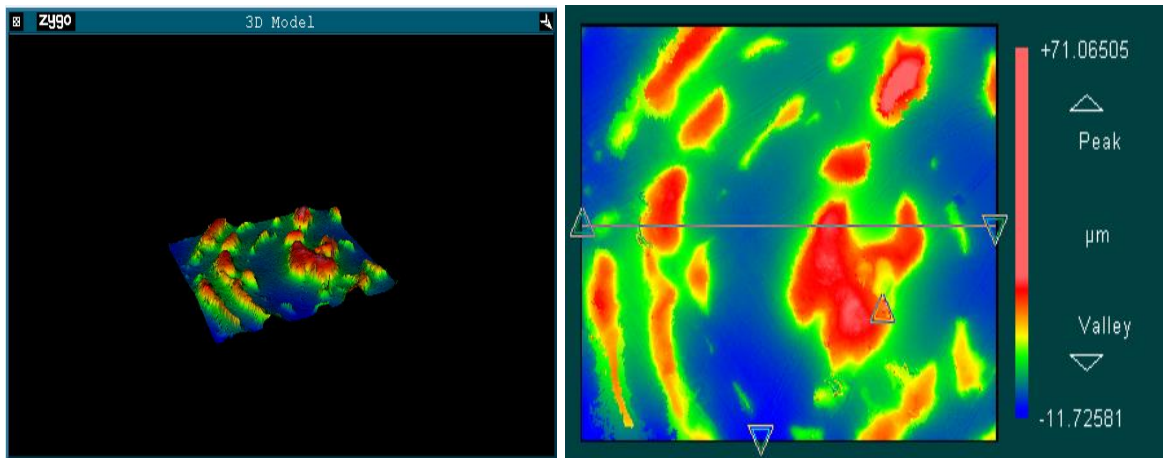
Figure 136: Picture that grouped the 3D model and the Surface map of the contact surface of the pin OE24.

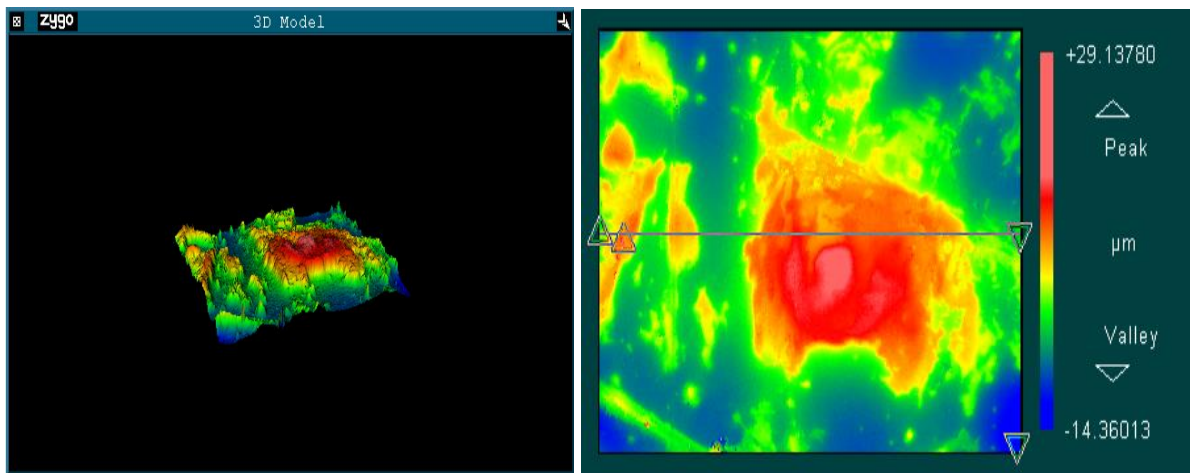
Figure 137: Picture that grouped the 3D model and the Surface map of the contact surface of the pin OE25.

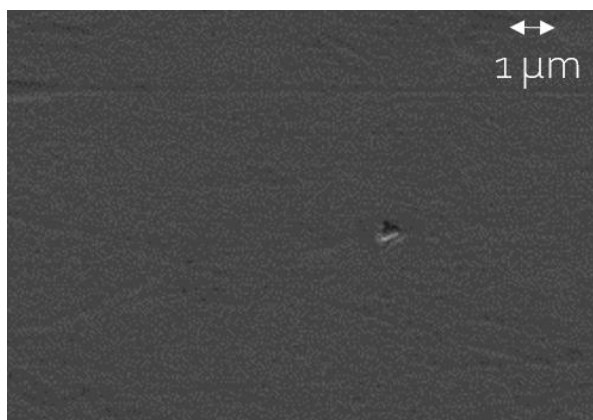
Figure 143: SEM image from Tech #3 coated disc surface.

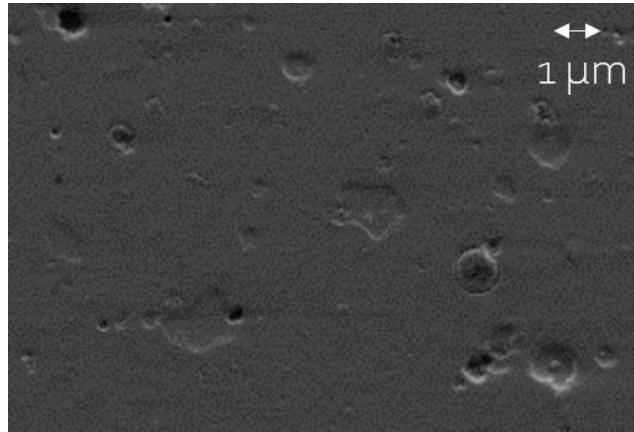
Figure 144: SEM image from Tech #1 coated disc surface.
