Assessment of Defects in Steel Structures Using UAVs and Image-Based 3D Reconstruction

THESIS

Submitted as partial fulfillment of the requirements
for the degree of Master of Science in Civil Engineering
in the Graduate College of the
University of Illinois at Chicago, 2021

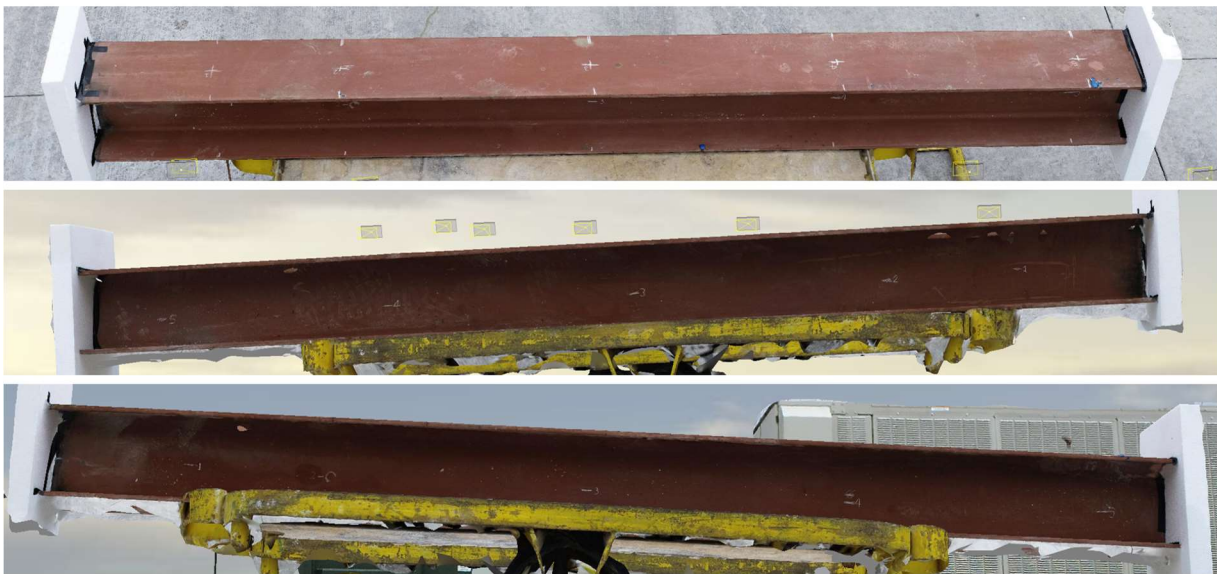
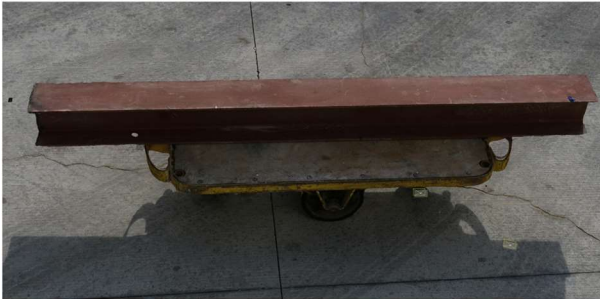
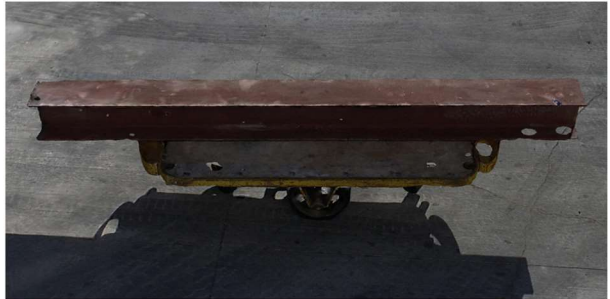
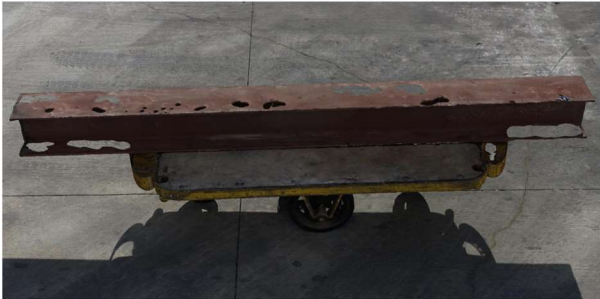
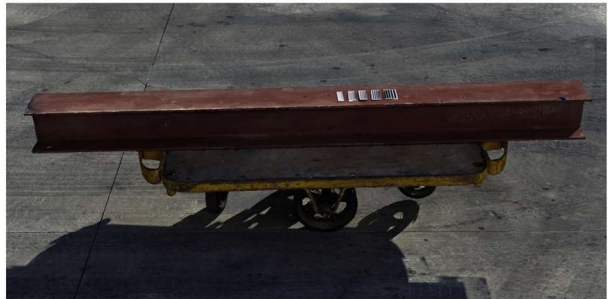
Figure 15. Oblique views of 3D constructed images showing holes on flanges.

Figure 15 and Figure 16 show the oblique views and the side views of 3D constructed models. The first data set made on consisted of 55 images. This model had the fewest number of holes of all the models. The second data set consisted of only 28 photos, the fewest of all the attempts. An effort was made to try and maintain consistent overlap, get closer, and go around the girder in a more organized way. This model had the highest number of holes at flanges and webs due to insufficient data points to connect planar data. The third data set consisted of 115

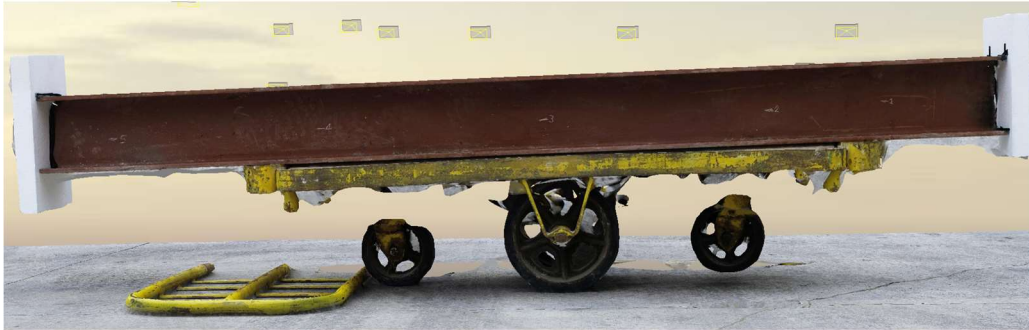
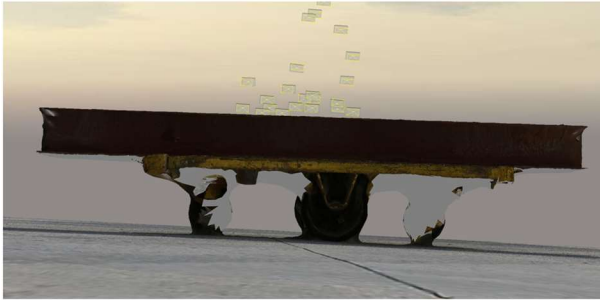
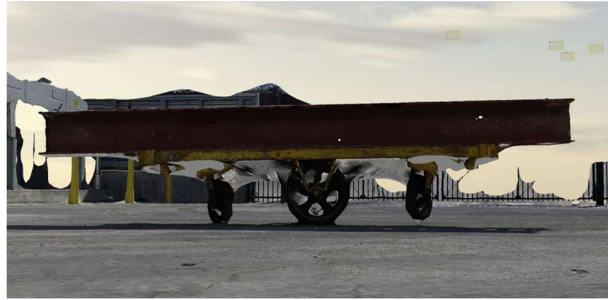
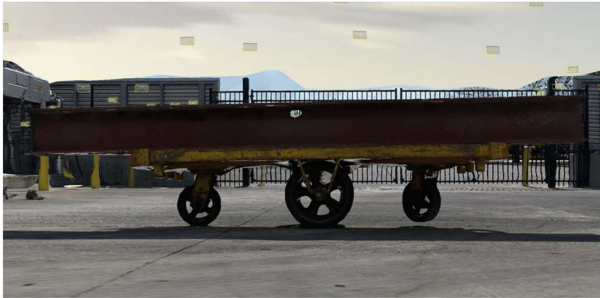
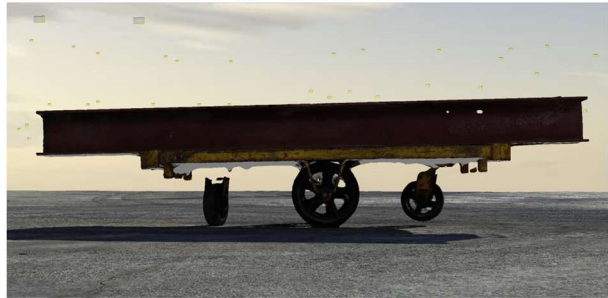
Figure 16. Side views of 3D constructed images indicating holes on the web.

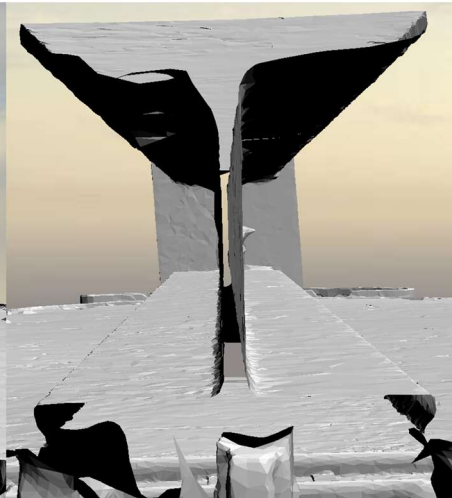
Figure 18. End views of the girder in each of the four models with texture off.

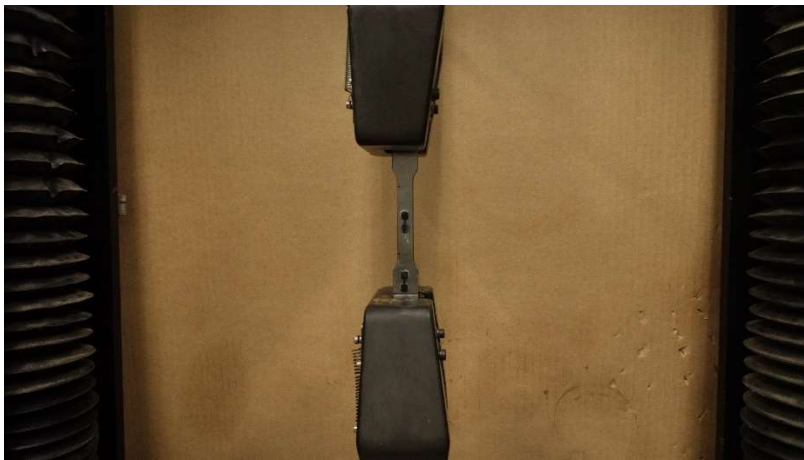
Figure 32. Experimental setup for the first coupon.

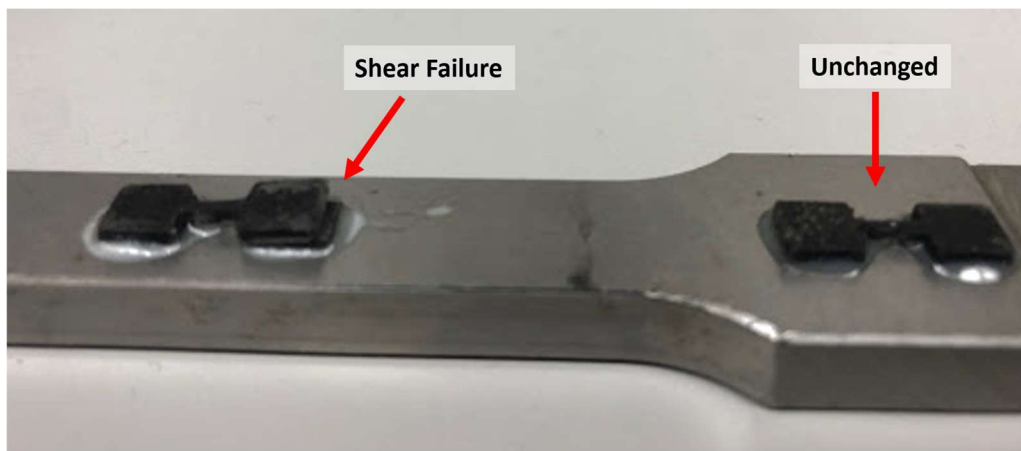
Figure 33. Results from the first experiment. The sensor at the gauge area failed due to shear at one of the ends instead of breaking at the middle. The other sensor outside the gauge area remained unchanged which validates the concept.

may have caused the part to be weaker in the plane of the shear failure and possibly due to a defect during manufacturing or both. The sensor outside of the gauge length was unaffected, which shows that the concept is viable. More work is needed in order to fine tune the strand to break at the exact moment of yielding but this was not the focus of these experiments. Rather, these trials are focused on the initial problem of adhering the sensor to the coupon and determining the failure modes of the sensor in experimental conditions.

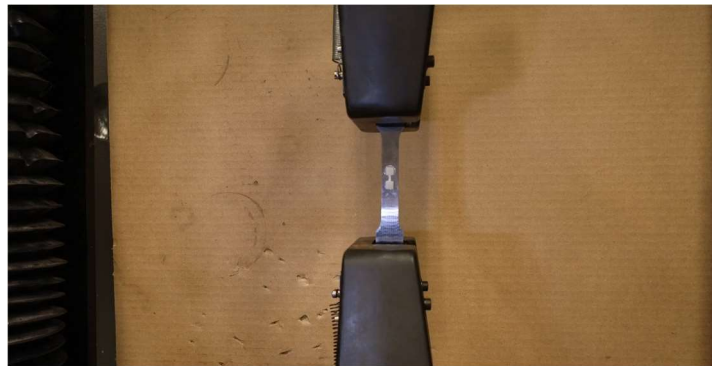
Figure 34. Experimental setup for the second and third coupons.

For the next trials, it was decided that to avoid the shear failure from the previous trial, the sensor should be manufactured from a solid sheet of material instead. Using CNC milling, sensors were able to be manufactured from a sheet of opaque, white acrylic. Since the material was opaque, there was no need to spray paint the part for visibility. This time, just one sensor was bonded to the coupon and the experiment was focused on achieving the desired failure mode as shown in Figure 34. This was that the sensor would break at the strand to indicate that the coupon has yielded. To observe the sensor's behavior more closely, an optical microscope was set up to capture footage of the failure as it happened. After running the tensile test, the results were as shown in Figure 35. The sensor did not break, but instead the adhesive bond failed. Two trials were done using the milled sensors with the same result. This means that a better method of attaching the sensor to the coupon is needed in order for the concept to work. In numerical models, the contact was assumed to be perfect and did not account for the properties of an adhesive or shifting like what was seen during footage of the experiment using the optical microscope. The shifting sensor is shown in Figure 36. For the concept to work, a stronger adhesive or another method of attachment would be needed. Ideally, the connection between the sensor and the coupon would need to have a shear strength greater than 345 MPa, the yielding strength of the A572 grade 50 steel, for the sensor to behave more similarly to the numerical model since it assumed a perfect bond.
